STATE OF CALIFORNIA
DEPARTMENT OF WATER RESOURCES
OROVILLE EMERGENCY RECOVERY – SPILLWAYS
TECHNICAL MEMORANDUM

Date: November 2, 2017

SUBJECT: Investigation and Initial Evaluation
Cracking of Erosion Resistant Concrete Invert Panels in the FCO
Spillway

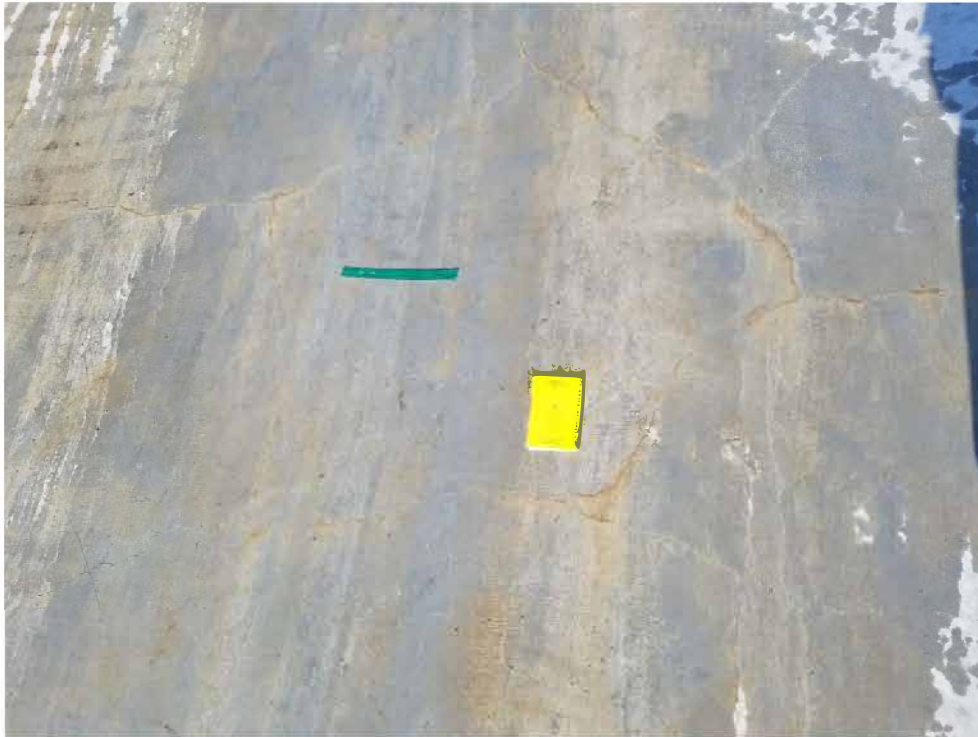
Figure 1: Typical Cracking Observed

It appears the majority of cracking visible is autogenous cracking, due primarily to the concrete being restrained by both underlying leveling concrete and anchors extending into the panel. After reviewing the mapping of cracks overlaid on the anchors, it is apparent that cracking is primarily between anchors supporting this theory.

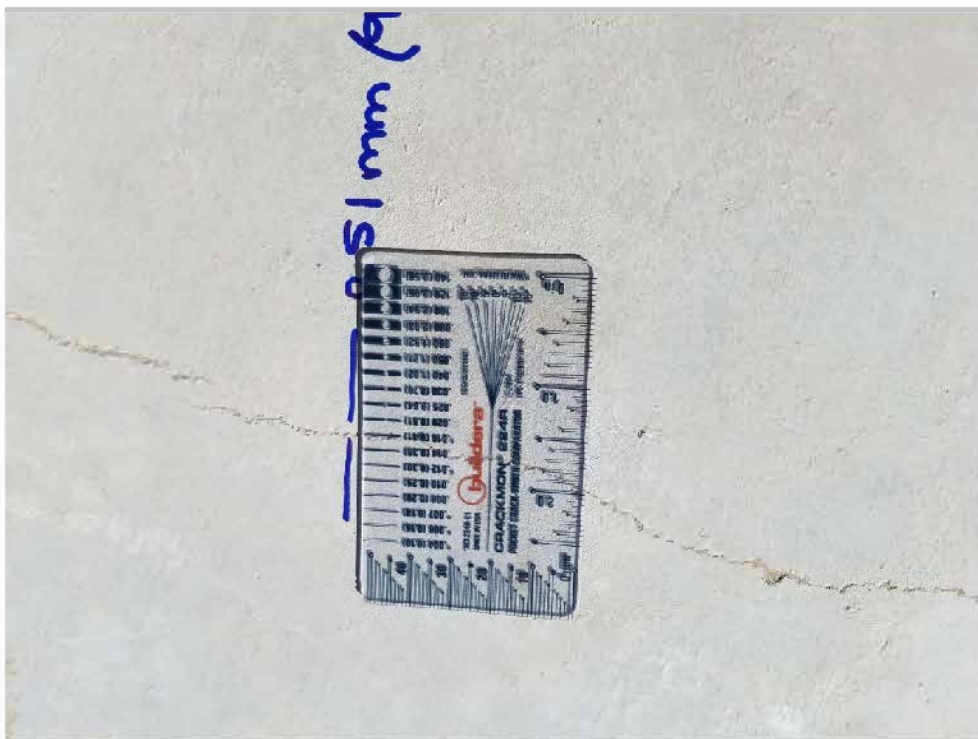
Figure 2: Typical Crack with Spalling and Raveling

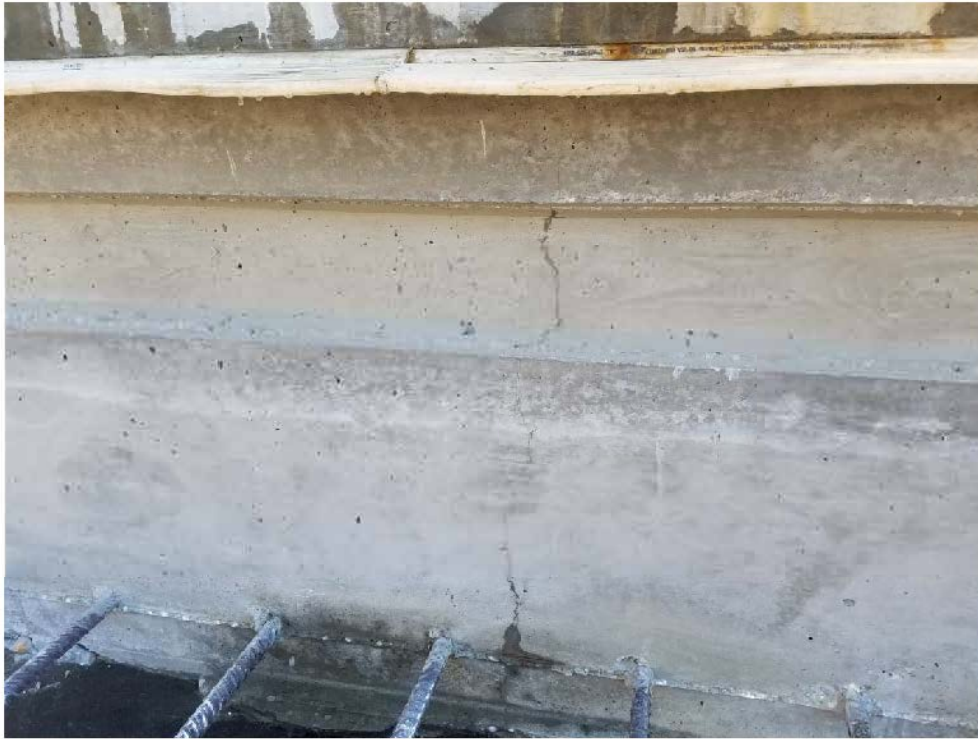
Figure 3: Typical Through Cracking Observed

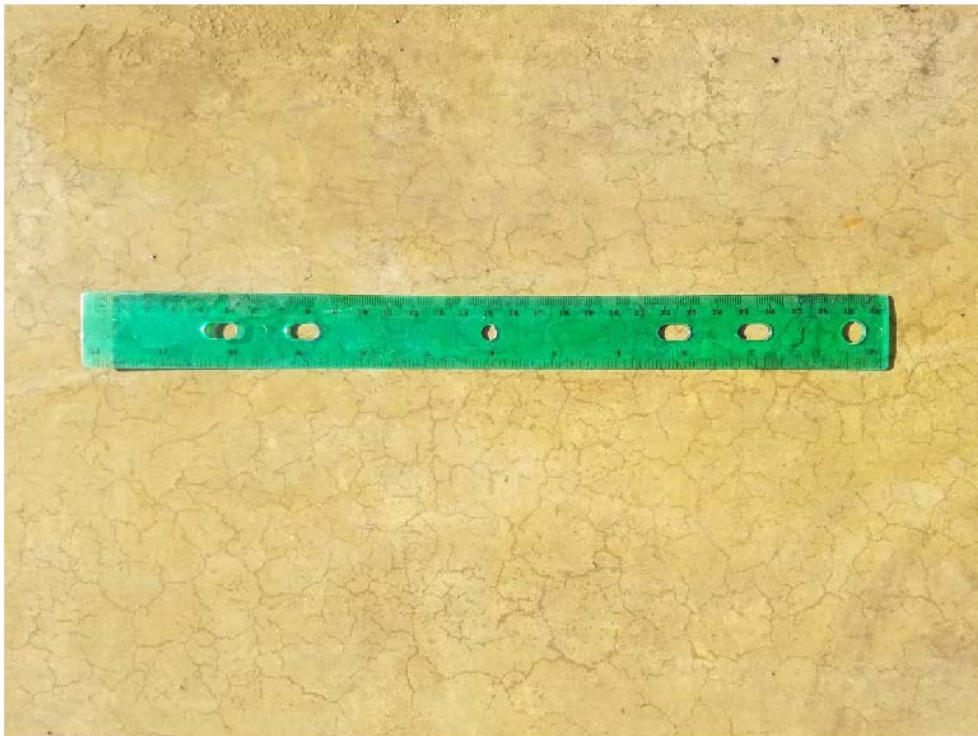
Figure 4: Typical Crazing Observed

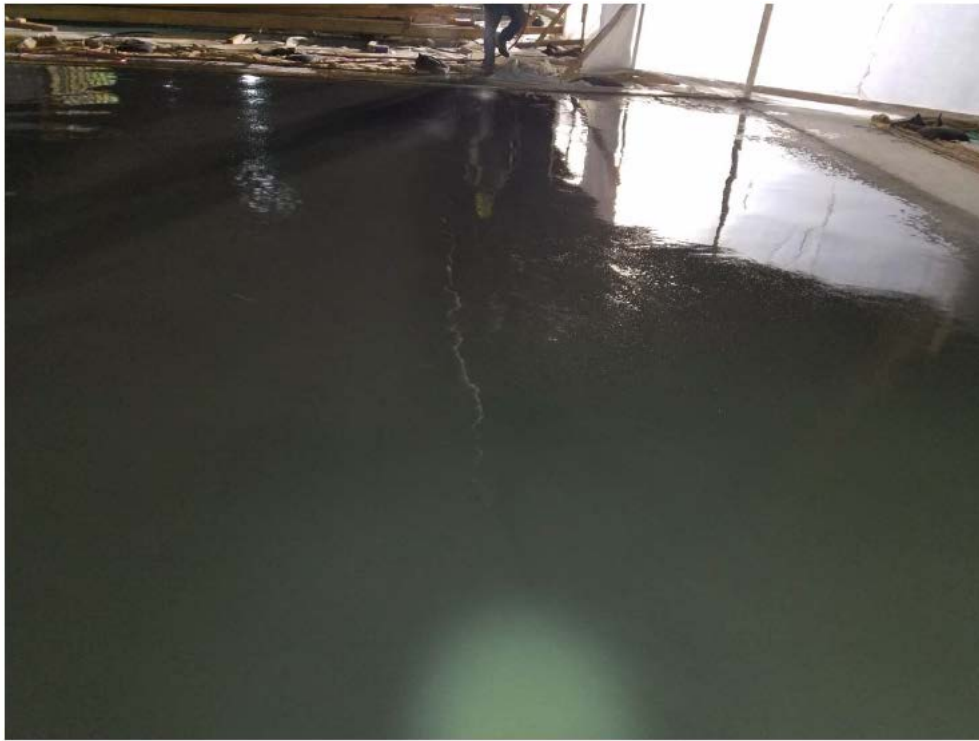
Windy placement conditions and delayed application of cure blankets may result in an increased evaporation on the finish surface, see Figure 5. In addition, poor water cure management for the duration of the required 14 days subjects the panels to potential drying and wetting cycles. Several instances occurred where the contractor did not immediately install water cure on the panel following the finishing efforts, as well as instances where the water cure was terminated or disrupted by other onsite operations introducing the variability in moisture cure. ACI 224.1R notes that “plastic shrinkage cracks begin as shallow cracks, but can become full-depth cracks later in the life of the concrete.” The contractor has attempted to mitigate the above mentioned moisture loss issues during placement and finishing efforts by using wind barriers and fogging, as well as securing the wet cure blankets to the surrounding formwork/panels as a post placement water cure management effort.

Figure 5: Cracking observed in 30C four hours after finishing

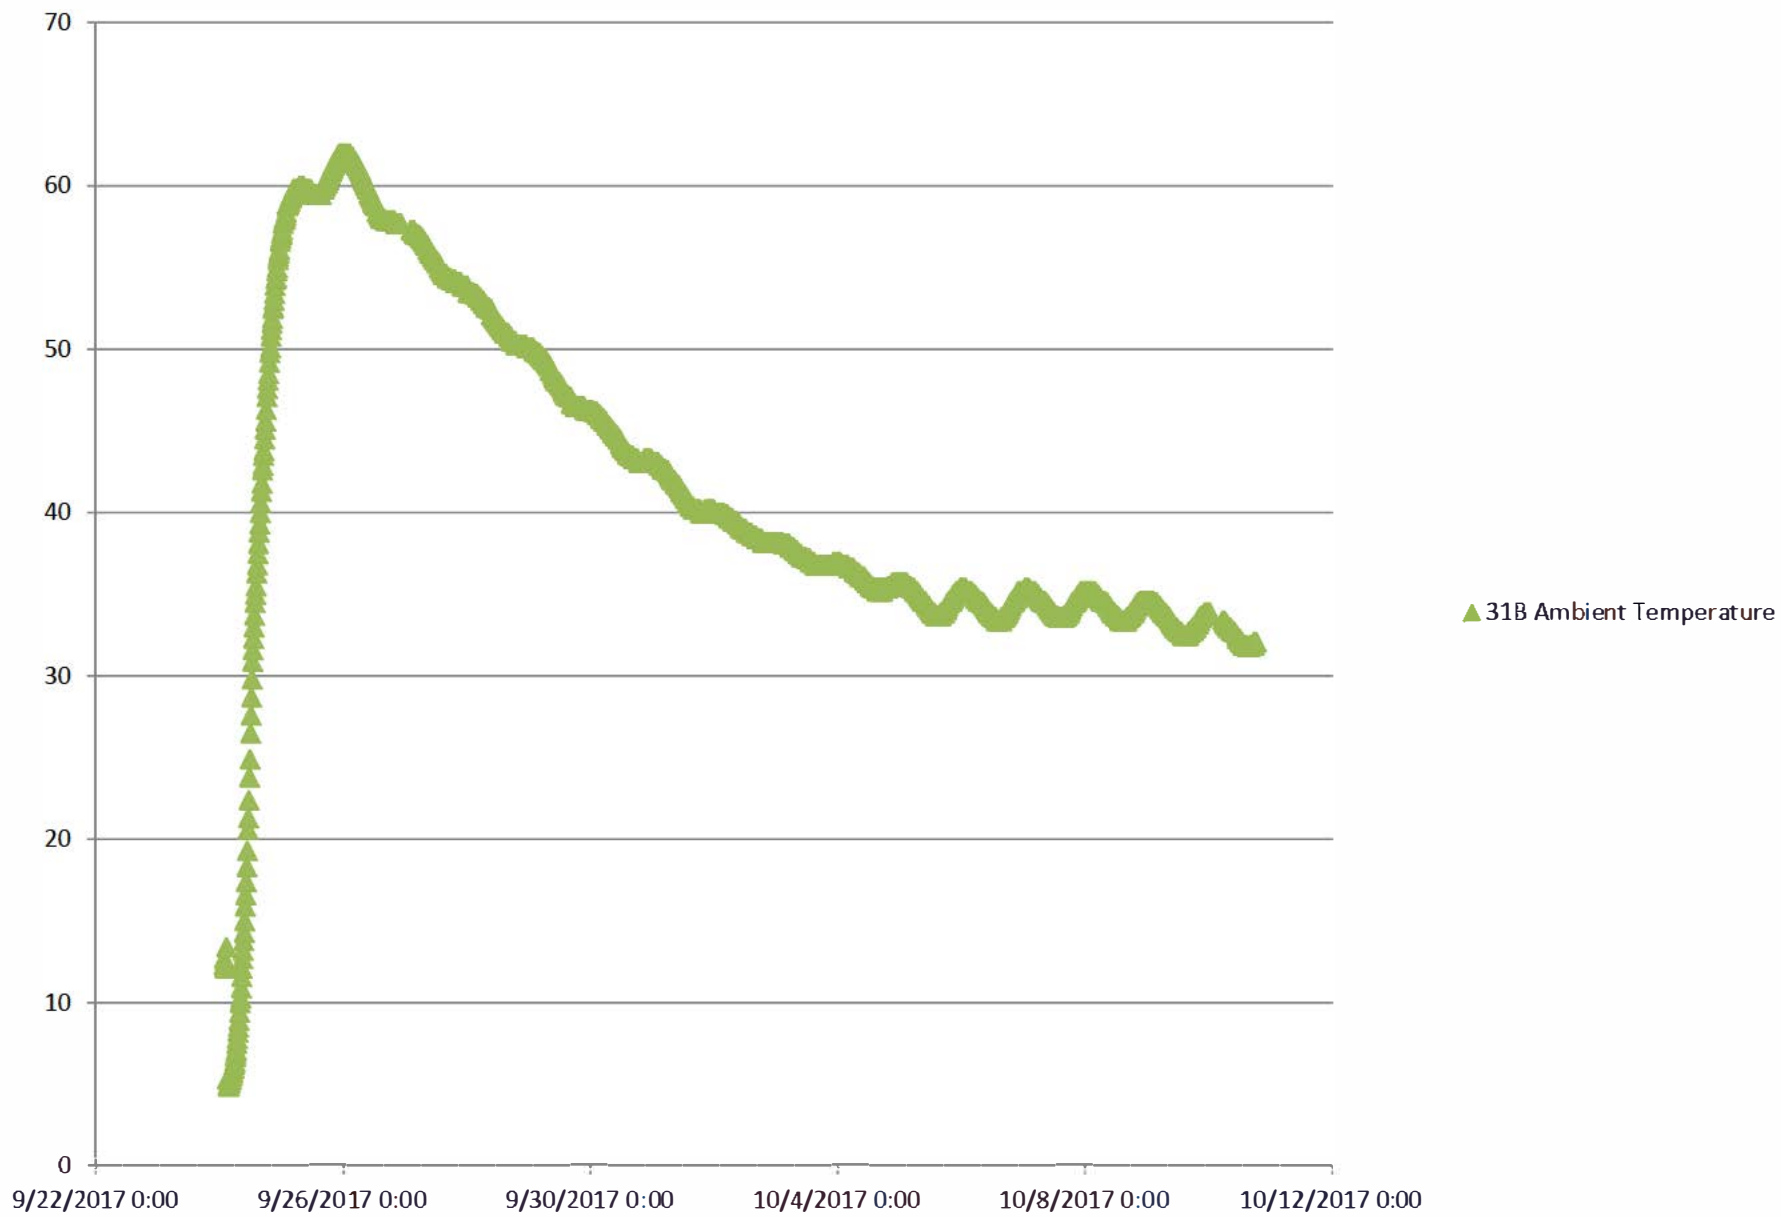
31B Heat of Hydration

Temperature gradients in a concrete structure can result in differential volumetric changes, resulting from heat of hydration and/or by the weather conditions. Currently, DWR has installed and monitored panels 31B, 44B, and 99B for temperature differentials. Panels 35D and 100D were recently installed and monitoring is underway. Attachment 2 shows both the heat of hydration change with time and the temperature increase (center of the panel) from the max placement temperature of the completed temperature monitored panels. Additionally, the instrumentation has reported the maximum thermal differential between near panel surface and internal reading of each panel as 16.4 degrees F, 18.7 degrees F, and 19 degrees F, respectively. DWR suspects that the lower temperature differential observed in panel 31B occurred because the location remained shaded for most of the day and the ambient temperatures were typically 4 and 7 degrees lower than the middle and lower chute locations, respectively. The thermal gradients never measured any greater than 35 degrees F, which suggests thermal shrinkage is not a primary cause of the observed

cracking. However, the temperature differential measured suggests that it is likely a contributor of the internal stresses, which caused cracking to occur.
