OROVILLE EMERGENCY RECOVERY – SPILLWAYS

Board of Consultants Memorandum

DATE: May 20, 2019

SUBJECT: Memorandum No. 23

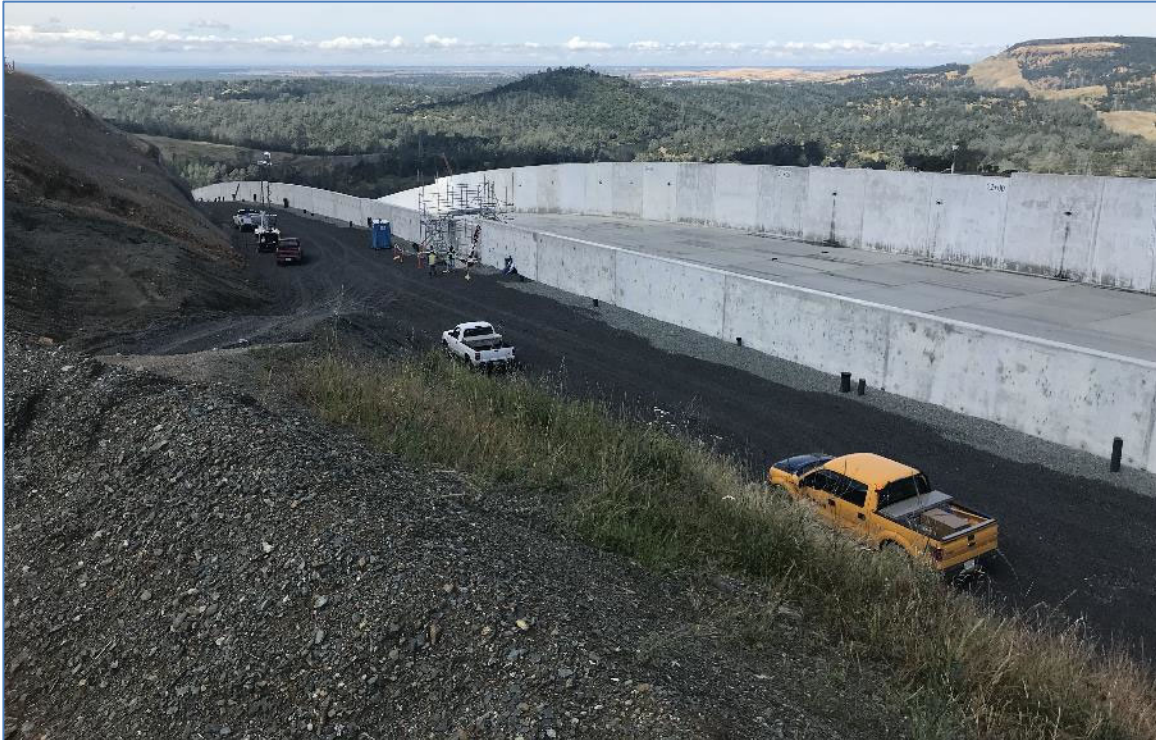
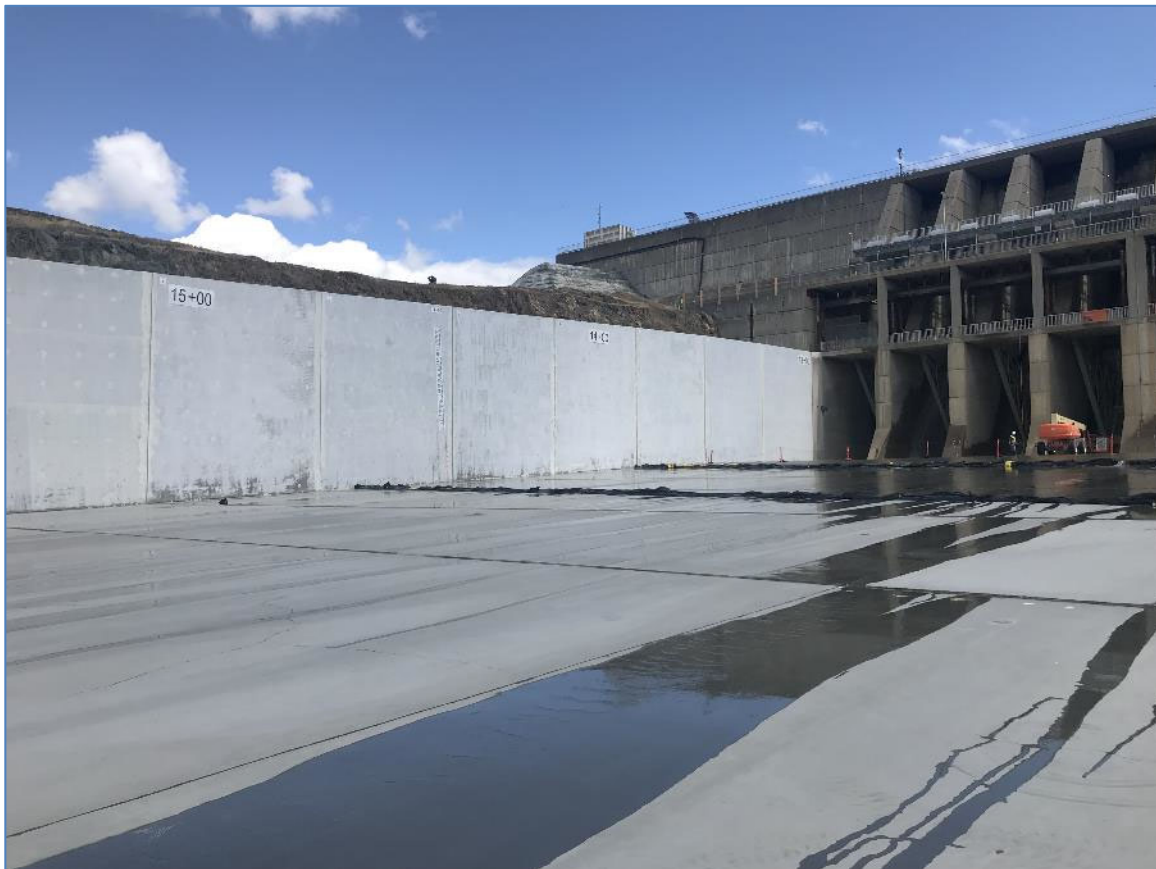
Figure 1. Photographs Taken During BOC Inspection of FCO

The BOC inspected the full length of the FCO Spillway on May 20, 2019 from inside the spillway. Select photographs taken by BOC members are presented on Figures 1 through 5. Collectively, the BOC noted only minor cosmetic differences from when the FCO spillway was inspected prior to passing flow. The differences included a handful of transverse joints missing several inches of flexible sealant, a spalled shallow small concrete repair, and a roughened surface of a slab finish (see photographs in Figures 4 and 5).

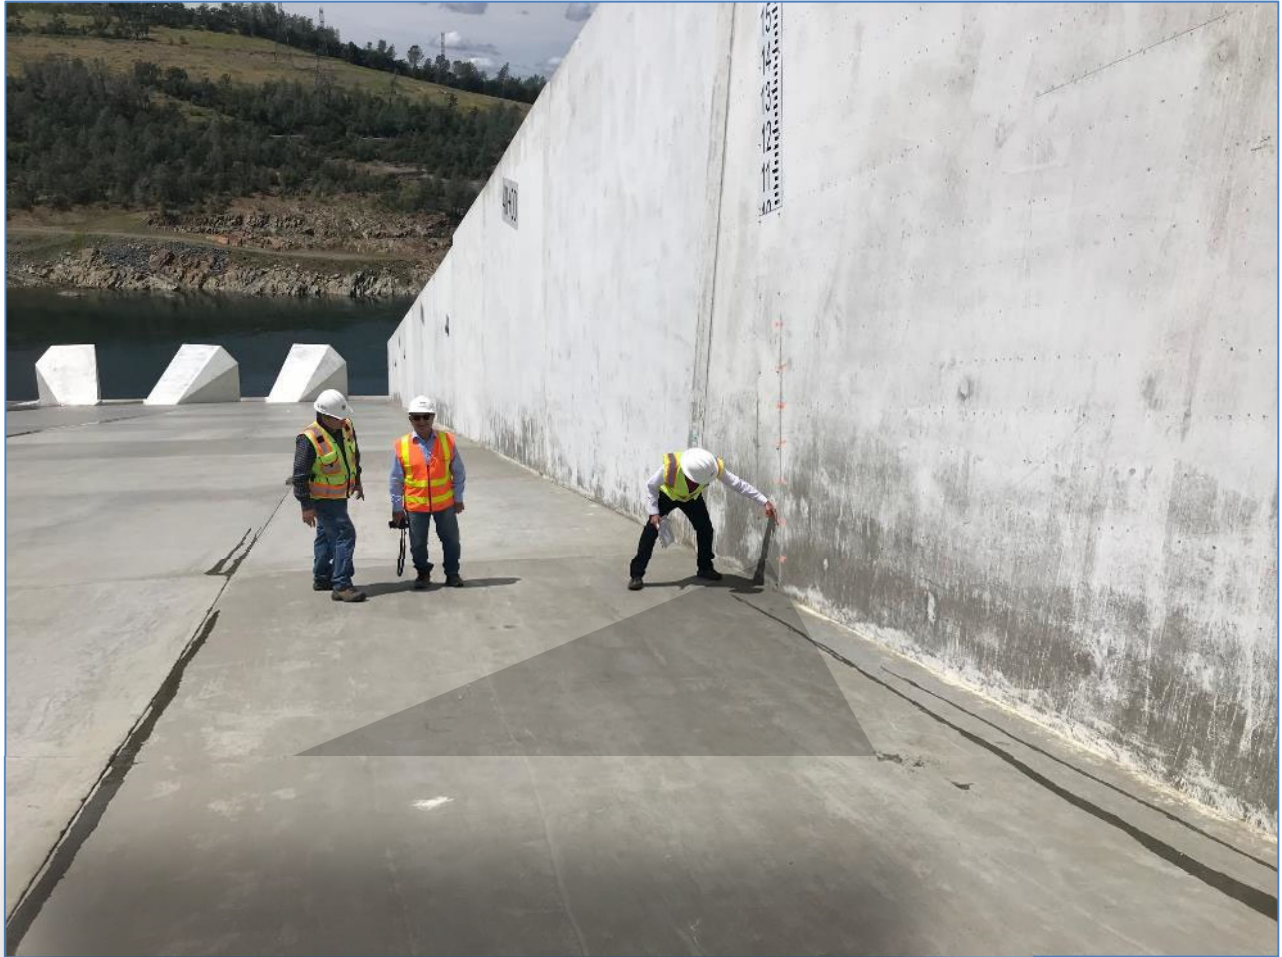
2. The BOC observed all the threaded bolts protruding from the spillway walls that were used to mount the staff gages on the inside face of the walls (see Figure 6). Although not intentional, these bolts provided an opportunity to monitor for cavitation damage since such a protrusion into the flow should initiate cavitation. All of the bolts at each staff gage mounting location that were below the flow line of the recent FCO spillway release showed no evidence of cavitation damage. The BOC recommends that the bolts used to fasten the staff gages to the inside face of the spillway walls be removed flush with the face of the wall, and that the staff gages be replaced with the staff gage information painted on the walls.

Figure 6. Photographs of staff gage anchoring bolts protruding from the spillway wall.

M23-2 The BOC recommends that the bolts used to fasten the staff gages to the inside face of the spillway walls be removed flush with the face of the walls and that the staff gages be replaced with the staff gage information painted on the walls.
