# OROVILLE EMERGENCY RECOVERY – SPILLWAYS

## Board of Consultants Memorandum

DATE: May 29-30, 2018

SUBJECT: Memorandum No. 18

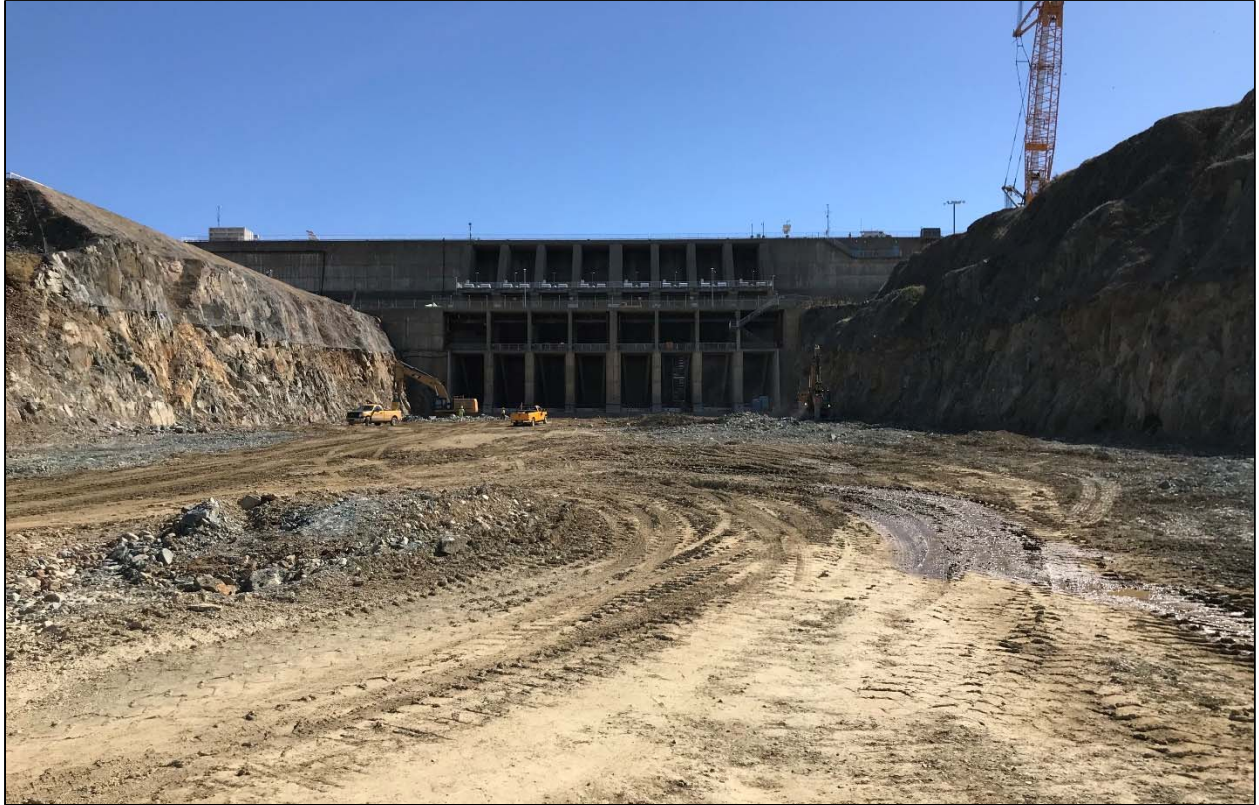
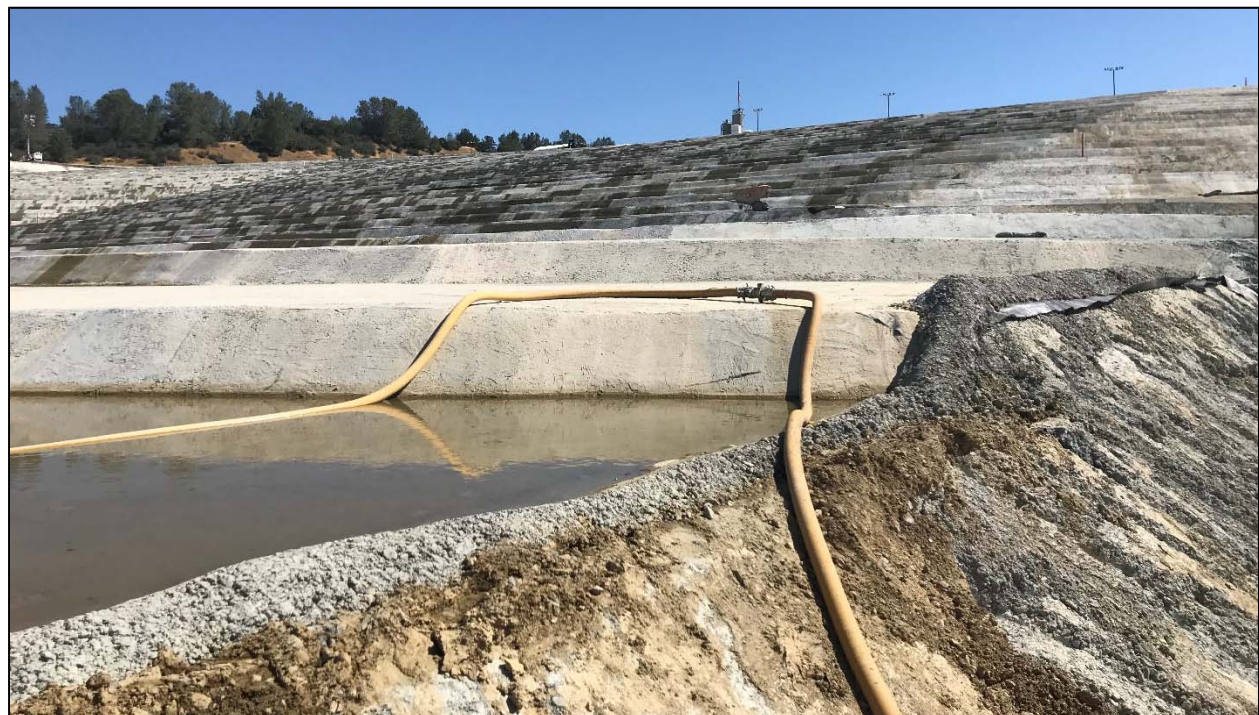
- completed demolition of the upper section of the FCO spillway chute;
- completed 82 percent of the RCC apron placement for Phase 1 on the right side of the Emergency Spillway;
- completed milling of the RCC FCO chute foundation;
- removed the temporary RCC spillway walls;
- milled many of the underdrain trenches in the FCO RCC foundation;
- began drilling slab anchors in FCO RCC foundation;
- continued hydro-demolition work at the FCO dentates;
- obtained fly-ash source for RCC; and
- completed the FCO Gate Closure Plan.

Figure 1. Photographs of the completed demolition work at the upper section of the FCO chute (top) and the RCC apron at the Emergency Spillway (bottom).

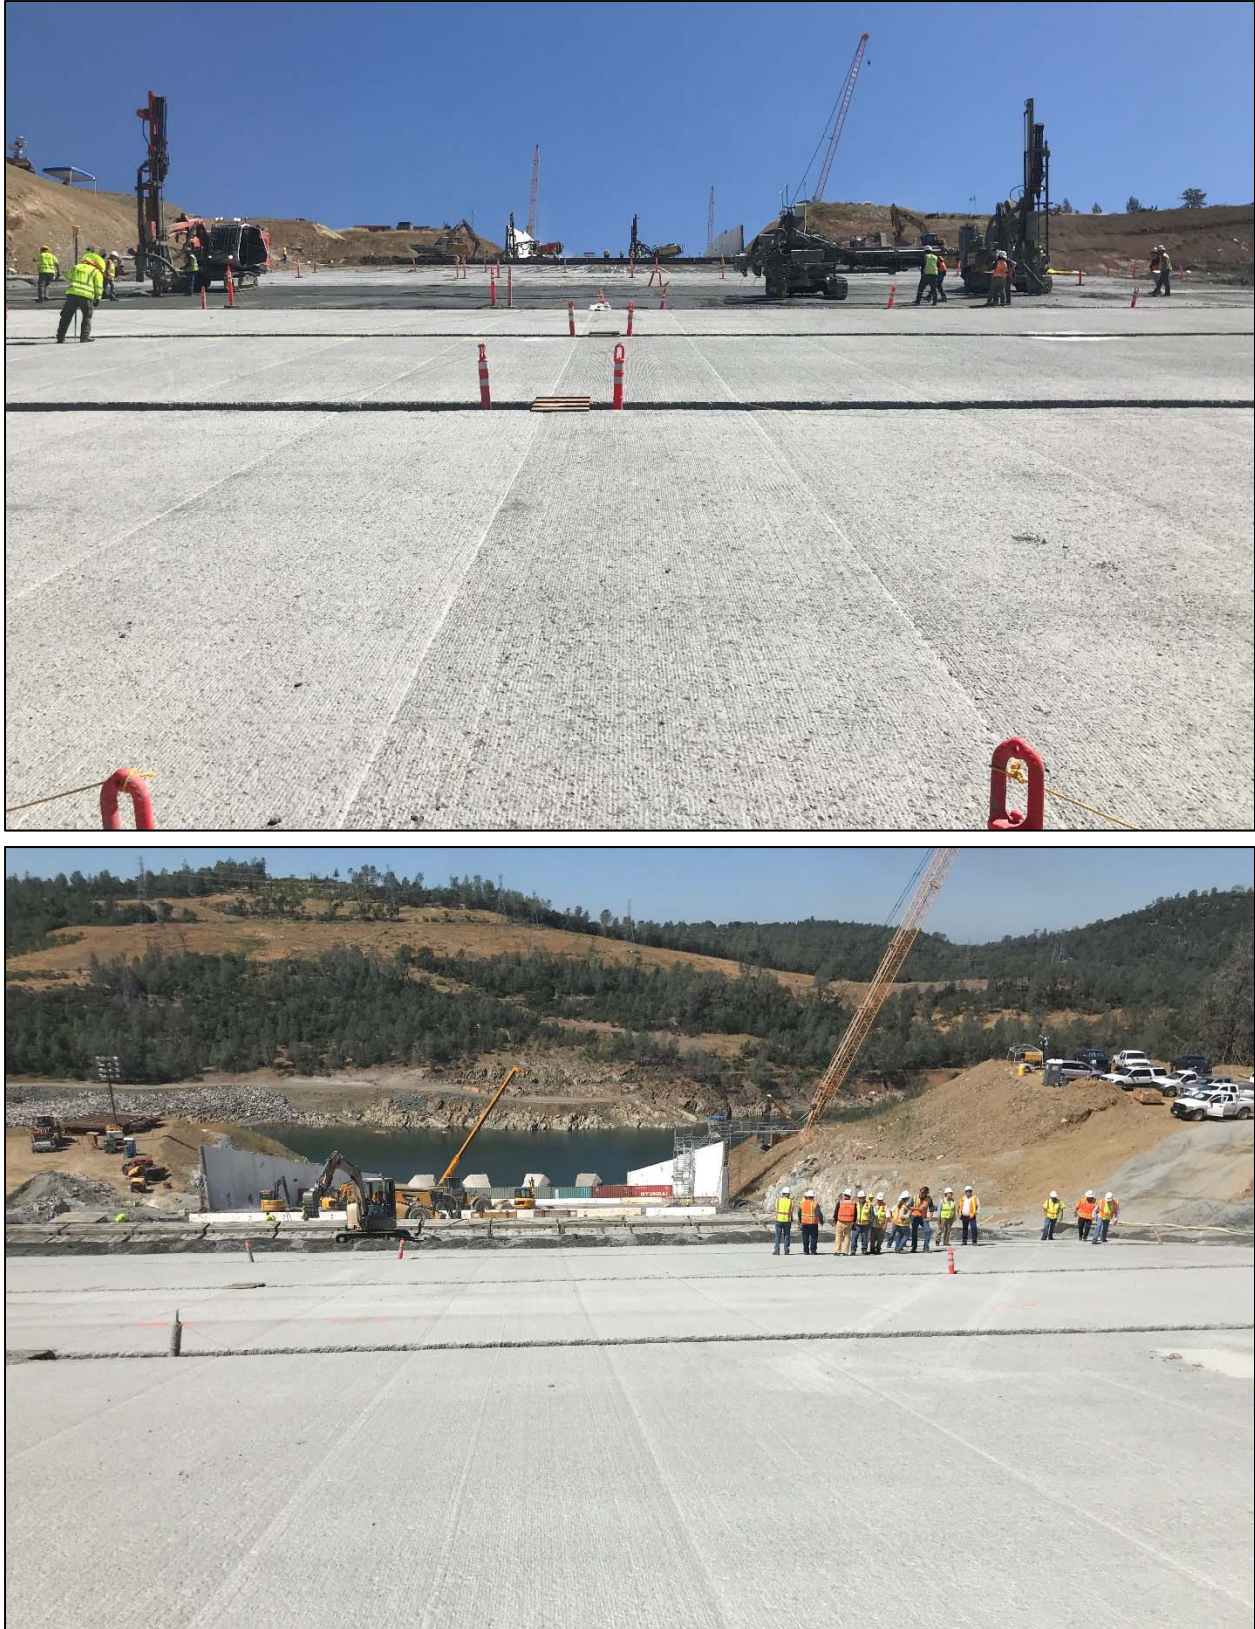
Figure 2. Photos showing RCC spillway walls removed from the FCO and the milled RCC foundation looking upstream (top), and downstream (bottom).

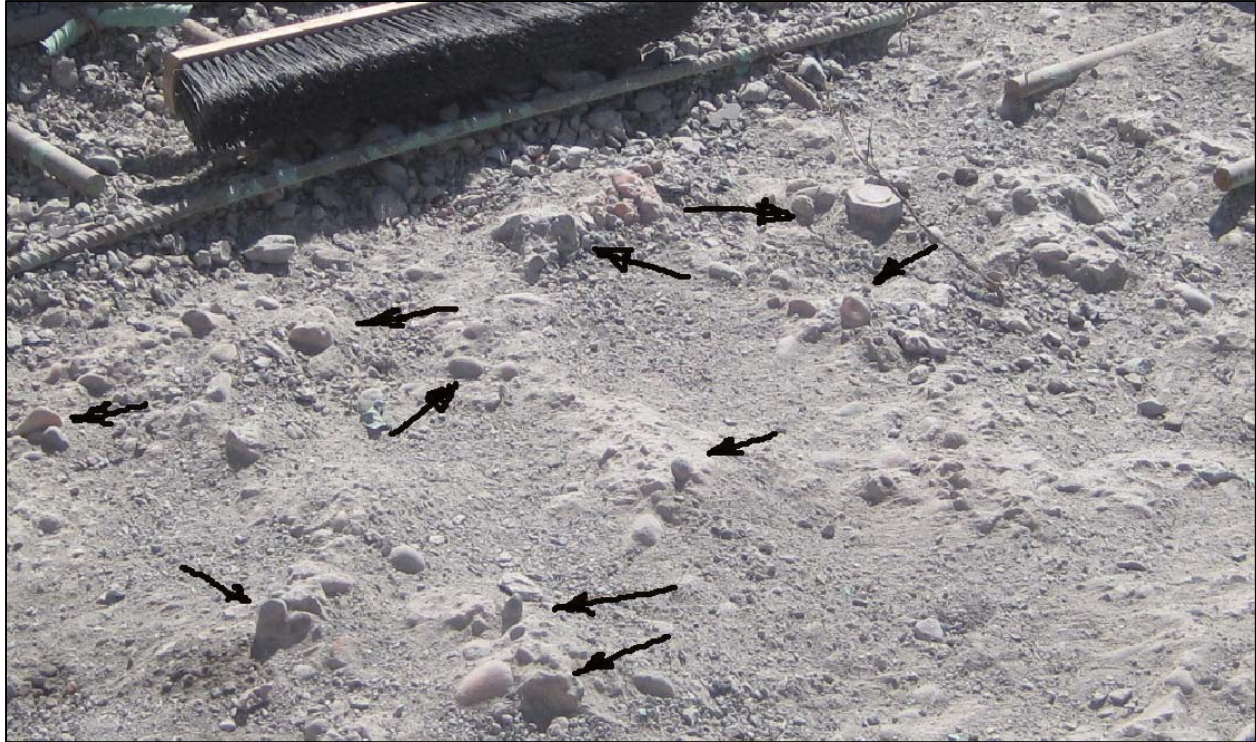
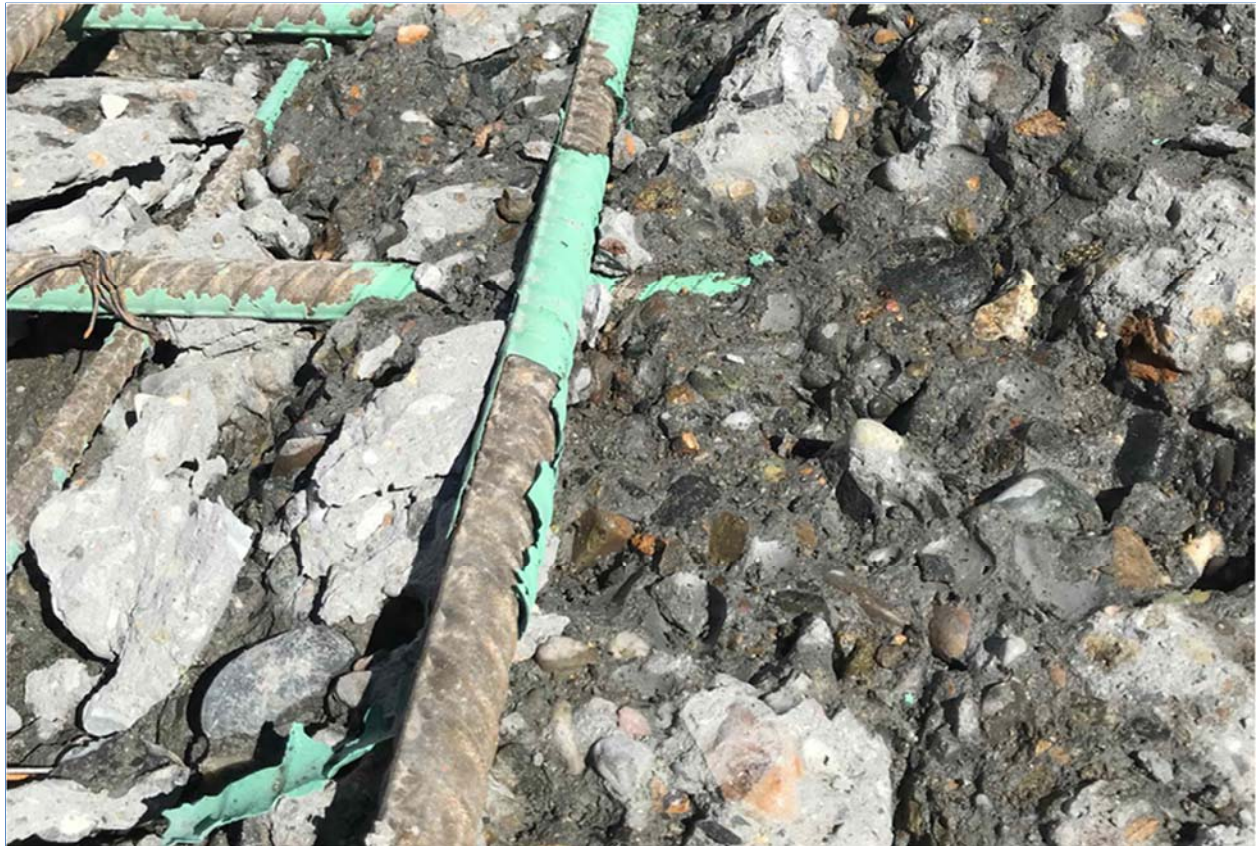
During the site visit, the BOC spoke with the specialty subcontractor performing the hydro-demolition work on a FCO concrete slab placed in 2017. The BOC was pleased to learn that the removal of the erosion resistant concrete was more difficult than expected, despite the contractor being aware of its high strength properties. Using a water jet pressure as high as 35,000 psi with the maximum water output possible, the hydro-demolition work required almost twice the time originally planned. According to the subcontractor, the concrete being removed was the most difficult and erosion resistant that he has encountered. While inspecting the excavated concrete surface, BOC members noted pieces of aggregate exposed over almost  $\frac{3}{4}$  of their surface area which could not be loosened with the kick of a boot (see Figure 3).

Figure 3. Photographs of the hydro-demolition equipment used on the FCO chute slab (top), and the excavated surface showing exposed aggregate tenaciously bonded to slab.

This information provides empirical evidence that the FCO chute concrete has superior erosion resistant properties. The BOC believes that this evidence should be considered by those involved in the aeration workshop and research. The BOC recommends that the spillway slab test section that was constructed to evaluate concrete mix designs not be demolished until the Design Team has an opportunity to consider its potential use for evaluating cavitation damage.

- M18-1 The BOC recommends that the spillway slab test section constructed to evaluate concrete mix designs not be demolished until the Design Team has an opportunity to consider its potential use for evaluating cavitation damage.
- M18-2 The BOC recommends a very robust design of the instrument [REDACTED] be investigated and developed.
- M18-3 The BOC recommends that the Design Team develop a tentative schedule for the proposed aeration research plan that outlines specific objectives with milestones.
- M18-4 The BOC recommends that a worst-case cavitation damage assessment be prepared for the FCO spillway for the probable maximum flood (PMF) scenario.

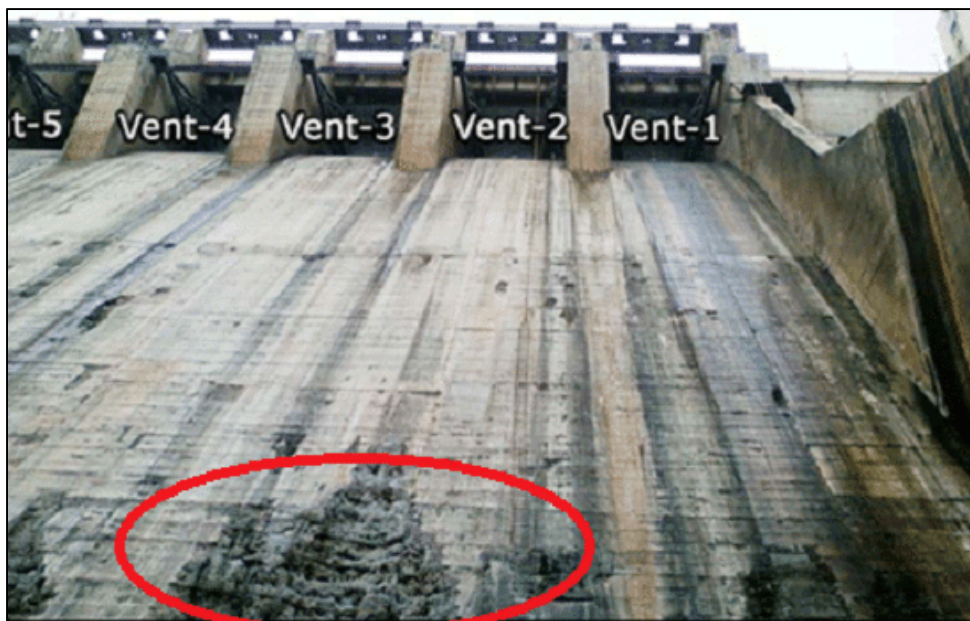
As part of the proposed research effort, the BOC recommends that a worst-case cavitation damage assessment be prepared for the probable maximum flood scenario. The BOC believes that given the erosion resistant of the chute slab concrete (as demonstrated by the difficult hydro-demolition of the slab surface at Panel 28E), the demanding placement tolerances and quality control for the new concrete slabs, and the relatively short duration of the PMF event, an outcome of the analysis will show that the maximum extent of cavitation damage to the spillway, assuming no aeration of the flow, could be limited to surface pitting and minor erosion, that may not require remediation following the flood event, or that can be easily repaired. This assessment should be related to case studies of cavitation damage that have been experienced at other spillways worldwide, such as the example shown on Figure 4. This important information should be considered in the deliberation over whether to modify the FCO spillway with aerators.

Figure 4. Example of cavitation damage in an open channel spillway chute (Source: The Constructor – “Cavitation Damage to Concrete Structures Prevention Methods”)
