OROVILLE EMERGENCY RECOVERY – SPILLWAYS

Board of Consultants Memorandum

DATE: February 23, 2018

SUBJECT: Memorandum No. 15

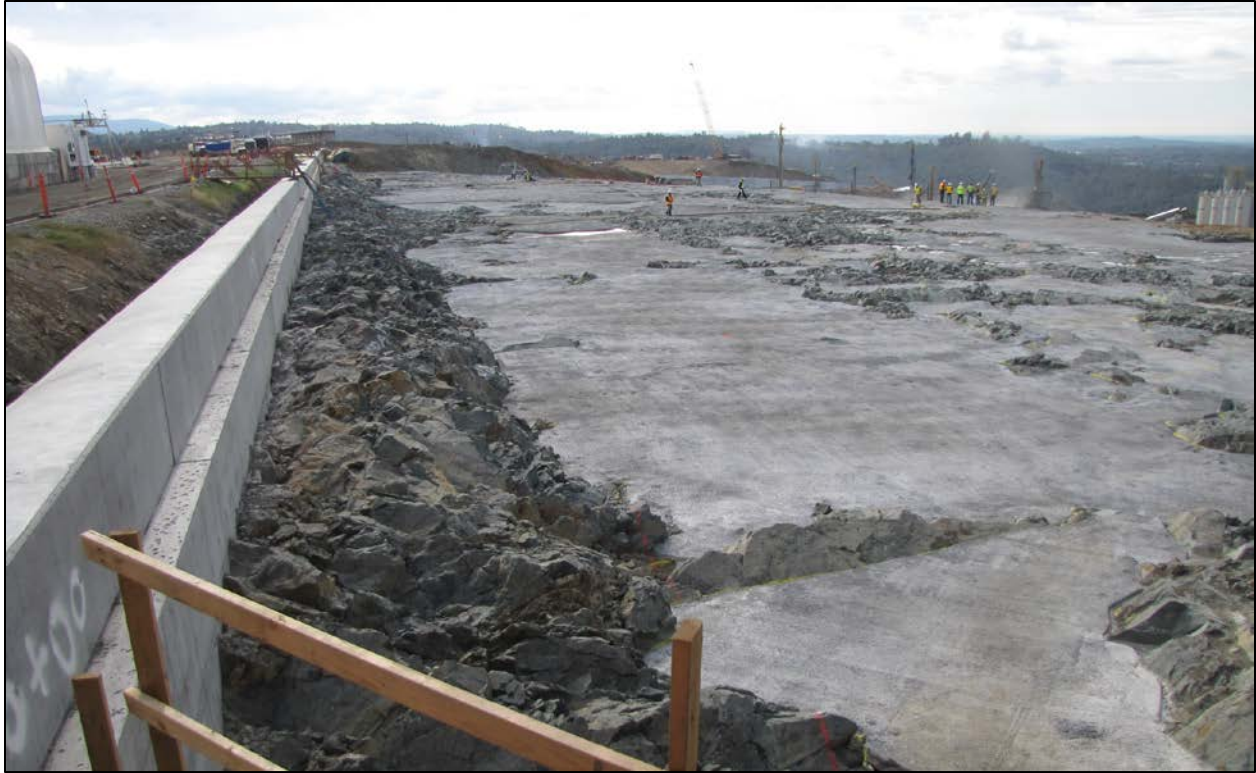
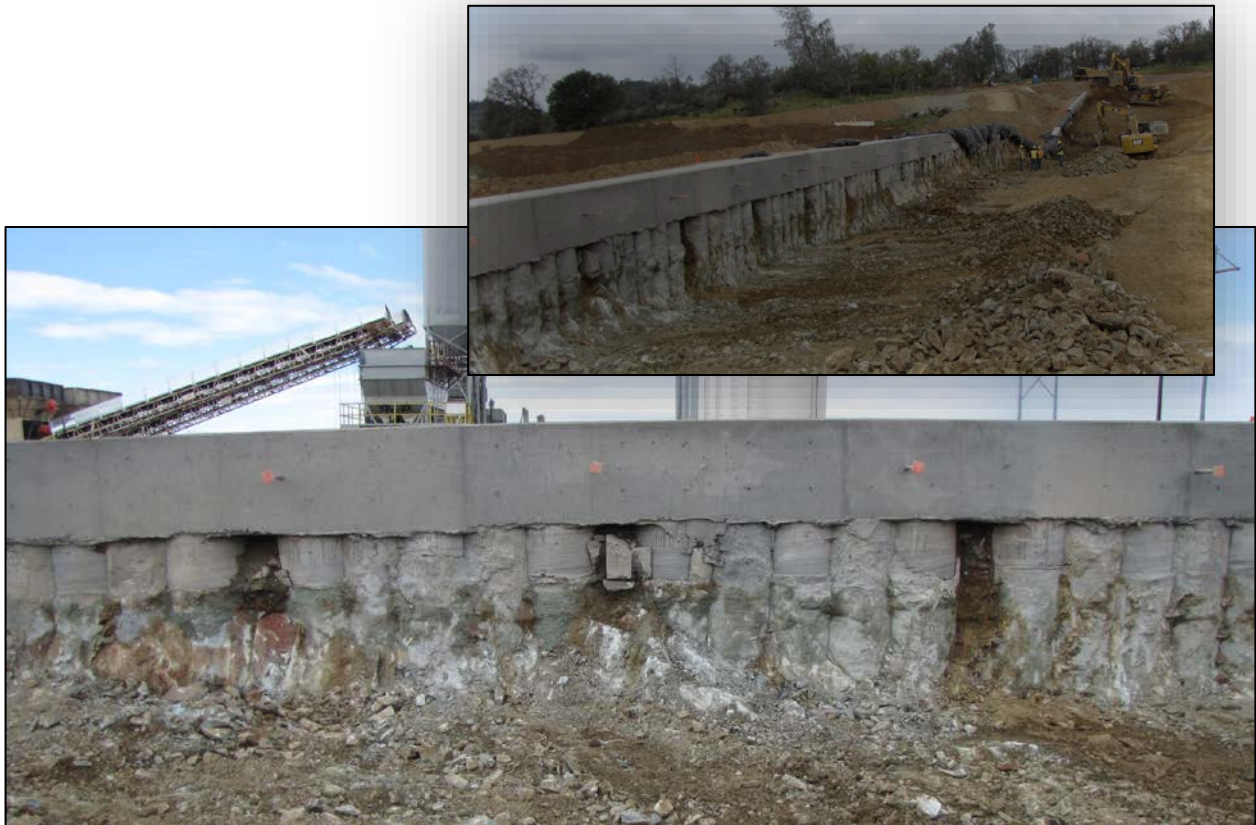
2. The Secant Pile Cutoff Wall is nearly complete (see Figure 1). The Secant Pile Wall has progressed so that only 11 piles remain to be completed. The follow-up work involving pile cutoff, placing dowels and rebar, and constructing the grade beam continues with anticipated completion in March.

Figure 1. Photographs of Emergency Spillway Control Section (Top) and Secant Pile Wall (Bottom)
