PROBLEMS OF THE LOWER SAN JOAQUIN RIVER

INFLUENCING THE 1963 SALMON RUN

THE RESOURCES **AGENCY** OF CALIFORNIA

January 15, 1964

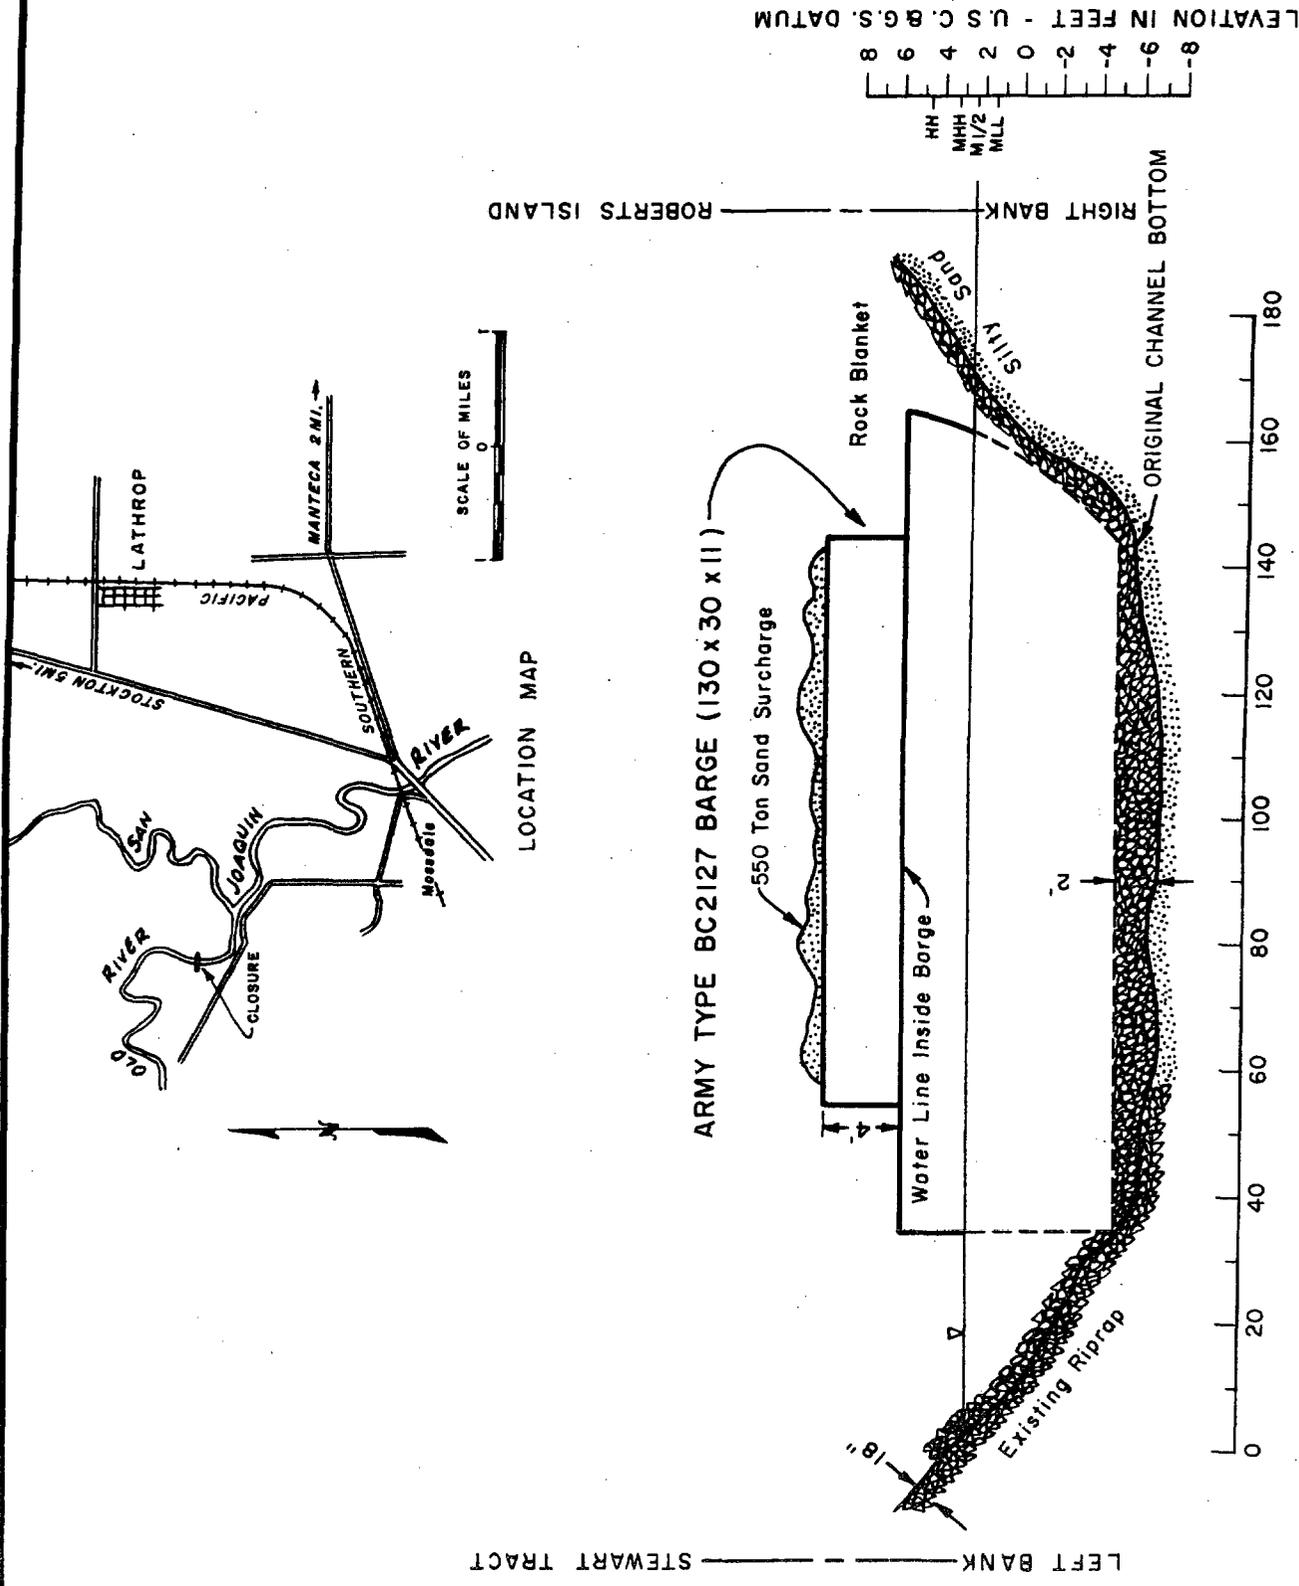
SCALE:  
HORIZONTAL : 1" = 30'  
VERTICAL : 1" = 10'

With the above site and hydraulic parameters, design of closure utilizing a 130-foot long by 30-foot wide by 11-foot deep type BC army barge was begun. The barge was provided by the U. S. Army facility located in Oakland, at no cost to the Department of Fish and Game, with the provision that the barge would be returned in like condition as borrowed and that the interior spaces would be re-oiled if needed to protect them from rust,

In comparison of two proposals (A - placing the barge on a sloping blanket, and B - placing the barge on a horizontal blanket with the assumption that a 2-foot layer of rock would be laid on the bottom of the channel), it was found that proposal A required 328 yards of rock and would yield a coefficient of friction equal to 0.25 and that proposal B would require a volume of 310 yards of rock and would yield the same coefficient of friction. It was, however, felt that it would be harder to place the rock in the shape of a sloping wedge than it would be to place it level on the channel bottom. For the latter reason and because of the smaller required yardage, it was decided to place the barge in a horizontal attitude. To further increase the factor of safety of sliding, it was decided that a minimum surcharge sand load of 250 tons would be placed on the barge. In addition, because of physical installation requirements and for additional safety, an anchor would restrict the barge on one end, and cables tied to a shore-located pier would restrict the barge on the other end. It was felt that the anchor and shore cable were necessary only on the upstream side of the barge, inasmuch as there was "no flow reversal.

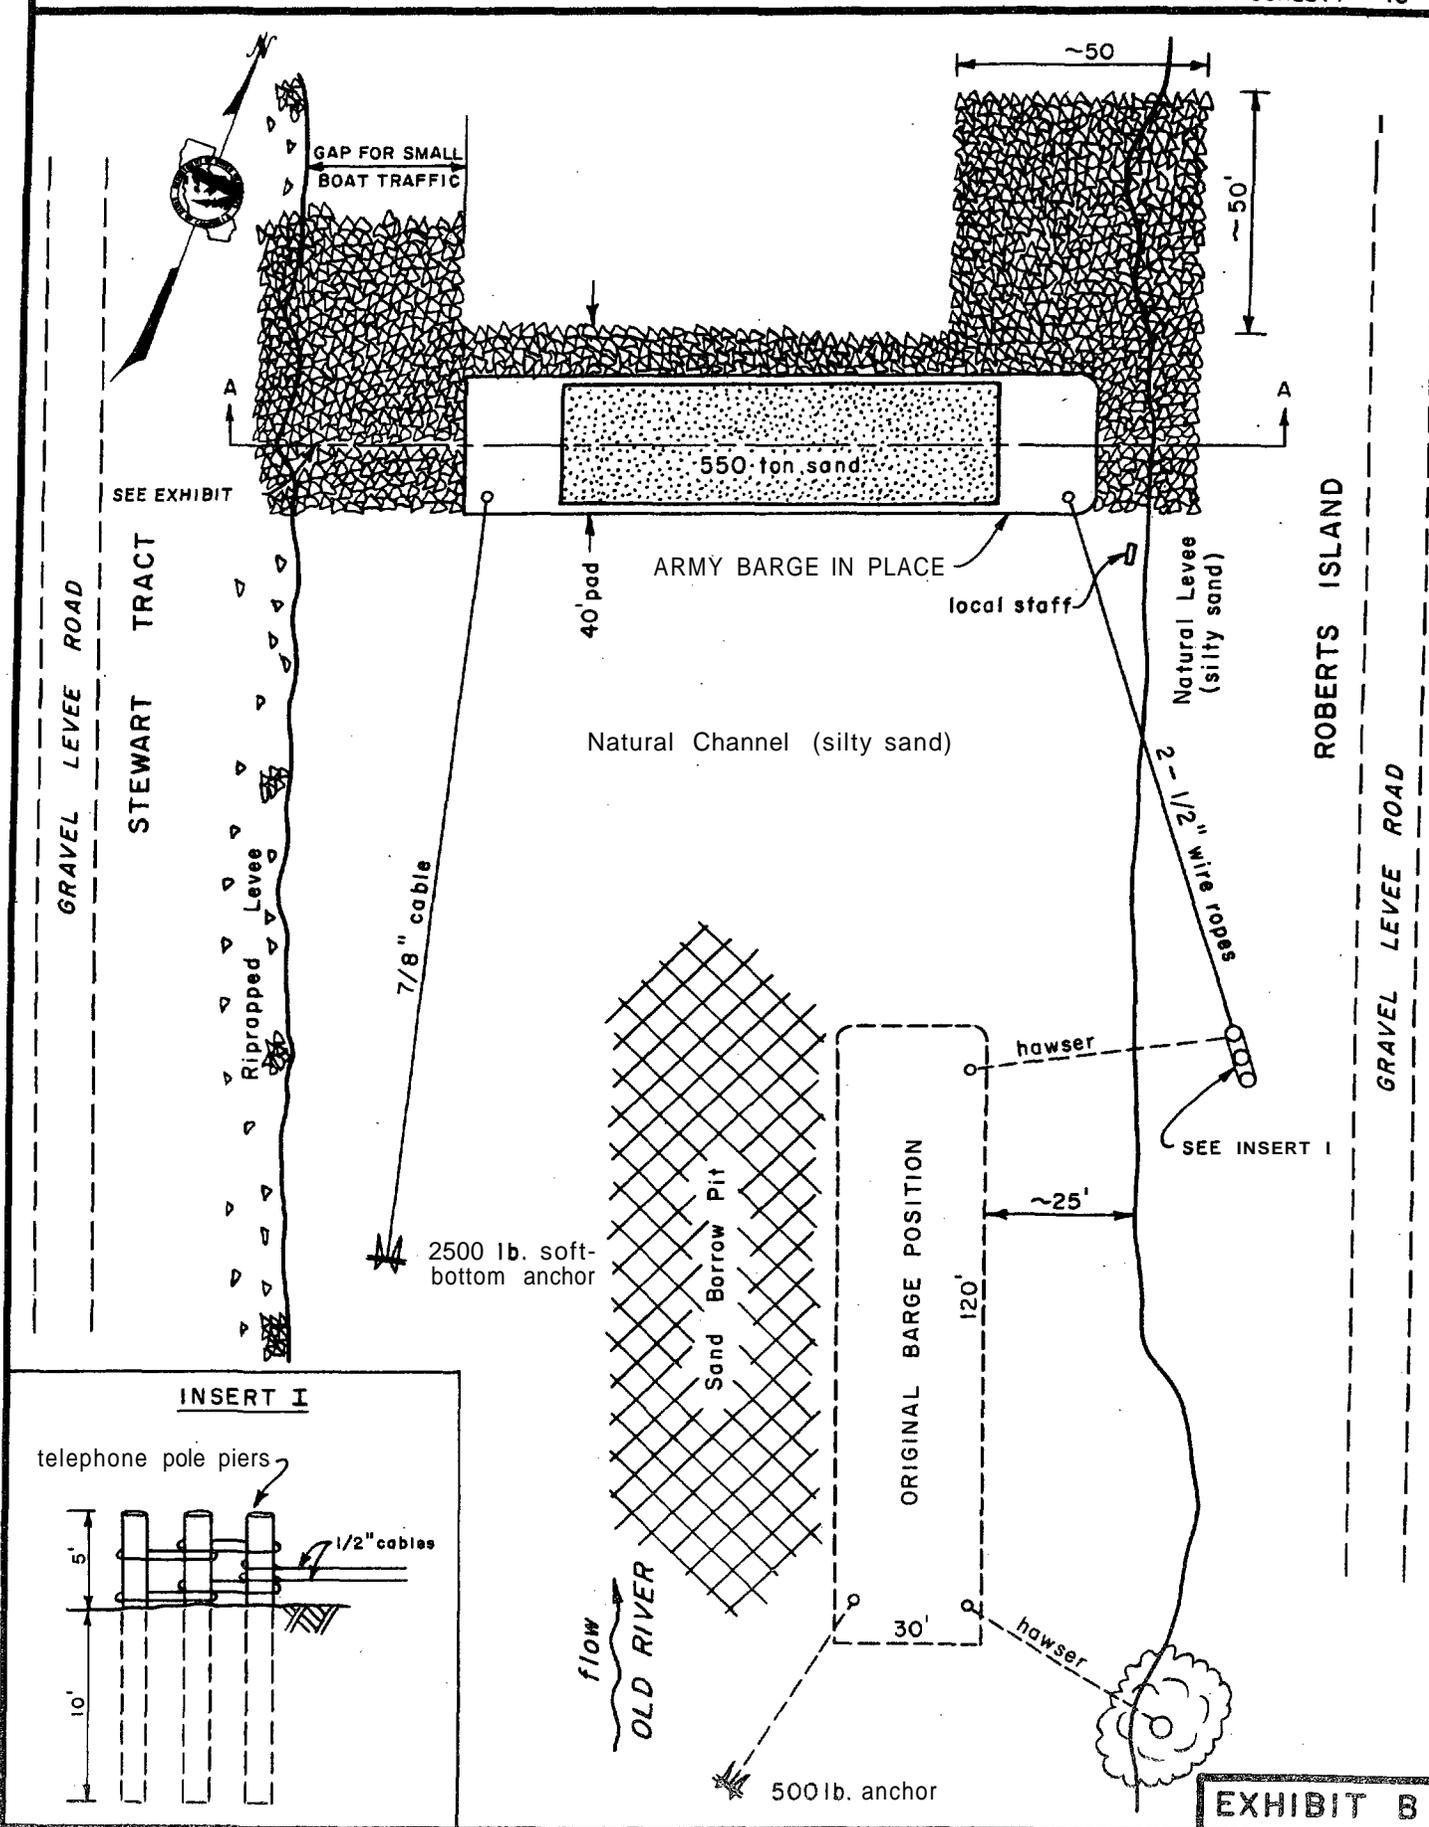
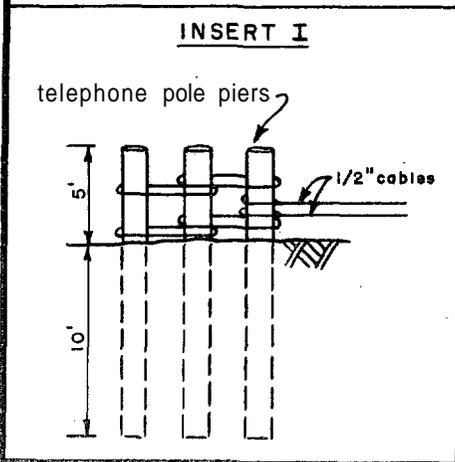
# PLAN VIEW-OLD RIVER CLOSURE

SCALE: 1" = 40'

Original plans called for charging the barge with 250 tons of sand and **then** filling **all** tanks until 1 foot of clearance could be obtained between the bottom of the barge hull and the top of the rock **pad**. When this was attempted, it was found **that** the barge was not designed for flooding the tanks. It, in fact, has no fore and aft bulkheads (that **is**, longitude **bulkheads**), and it was discovered that as little as 4 inches of water in the holds, combined with any undistributed load in excess of 10 tons on the deck, would "list" the barge drastically to port or **starboard**. Therefore, all tanks were subsequently pumped dry or as dry as possible. It cannot be stressed too **strongly** that in future installations of this kind in Old River, that sand barges, or like type barge which have no fore and aft bulkheads must be surcharged with all tanks completely dry in order to insure that capsizing **of** the barge will not occur. Since a normal load could not be obtained by charging the tanks of the barge with water, it was necessary to surcharge the surface of the barge with an additional amount of sand so that the 1-foot clearance **require-**ment could be met. It was felt that anything greater than 1-foot clearance between the **bottom** of the barge and the top of the rock pad would result **in** increasing the critical period of time when the barge must hover over the pad with nothing more to hold it against the **streamflow** but anchor cable, 1/2-inch wire ropes, and LCM. It was further decided that with 1-foot clearance and two anchor points that **water** charging **of** the barge tanks would be accomplished without undue danger **-of capsizing**.

On Thursday morning the crane was again utilized in surcharging the barge until a 6-1/2 foot draft was obtained. The surcharge load was relatively **uniformly distributed**. Anchors were then "set" and cable marked at the proper **length**. It was first thought that 500-pound anchors could be used to anchor the barge, **but** these were found to drag so a 2,500-pound anchor was rented from Basalt for the **job**. Flow velocities in mid-channel were recorded on Wednesday and it was found that minimum velocities would occur on Thursday at 1630 hours. It was decided that at 1430 hours the barge would be slid back into position and that pivoting into the final resting place would begin at approximately 1530 hours. It was estimated that enough water could be pumped into the hull of the barge so that the bow would be resting on the bottom by no later than 1630 hours. Pumping would begin from the right bank and proceed to the left bank. Mid-channel velocity during the installation time would be approximately 9/10 foot per second.

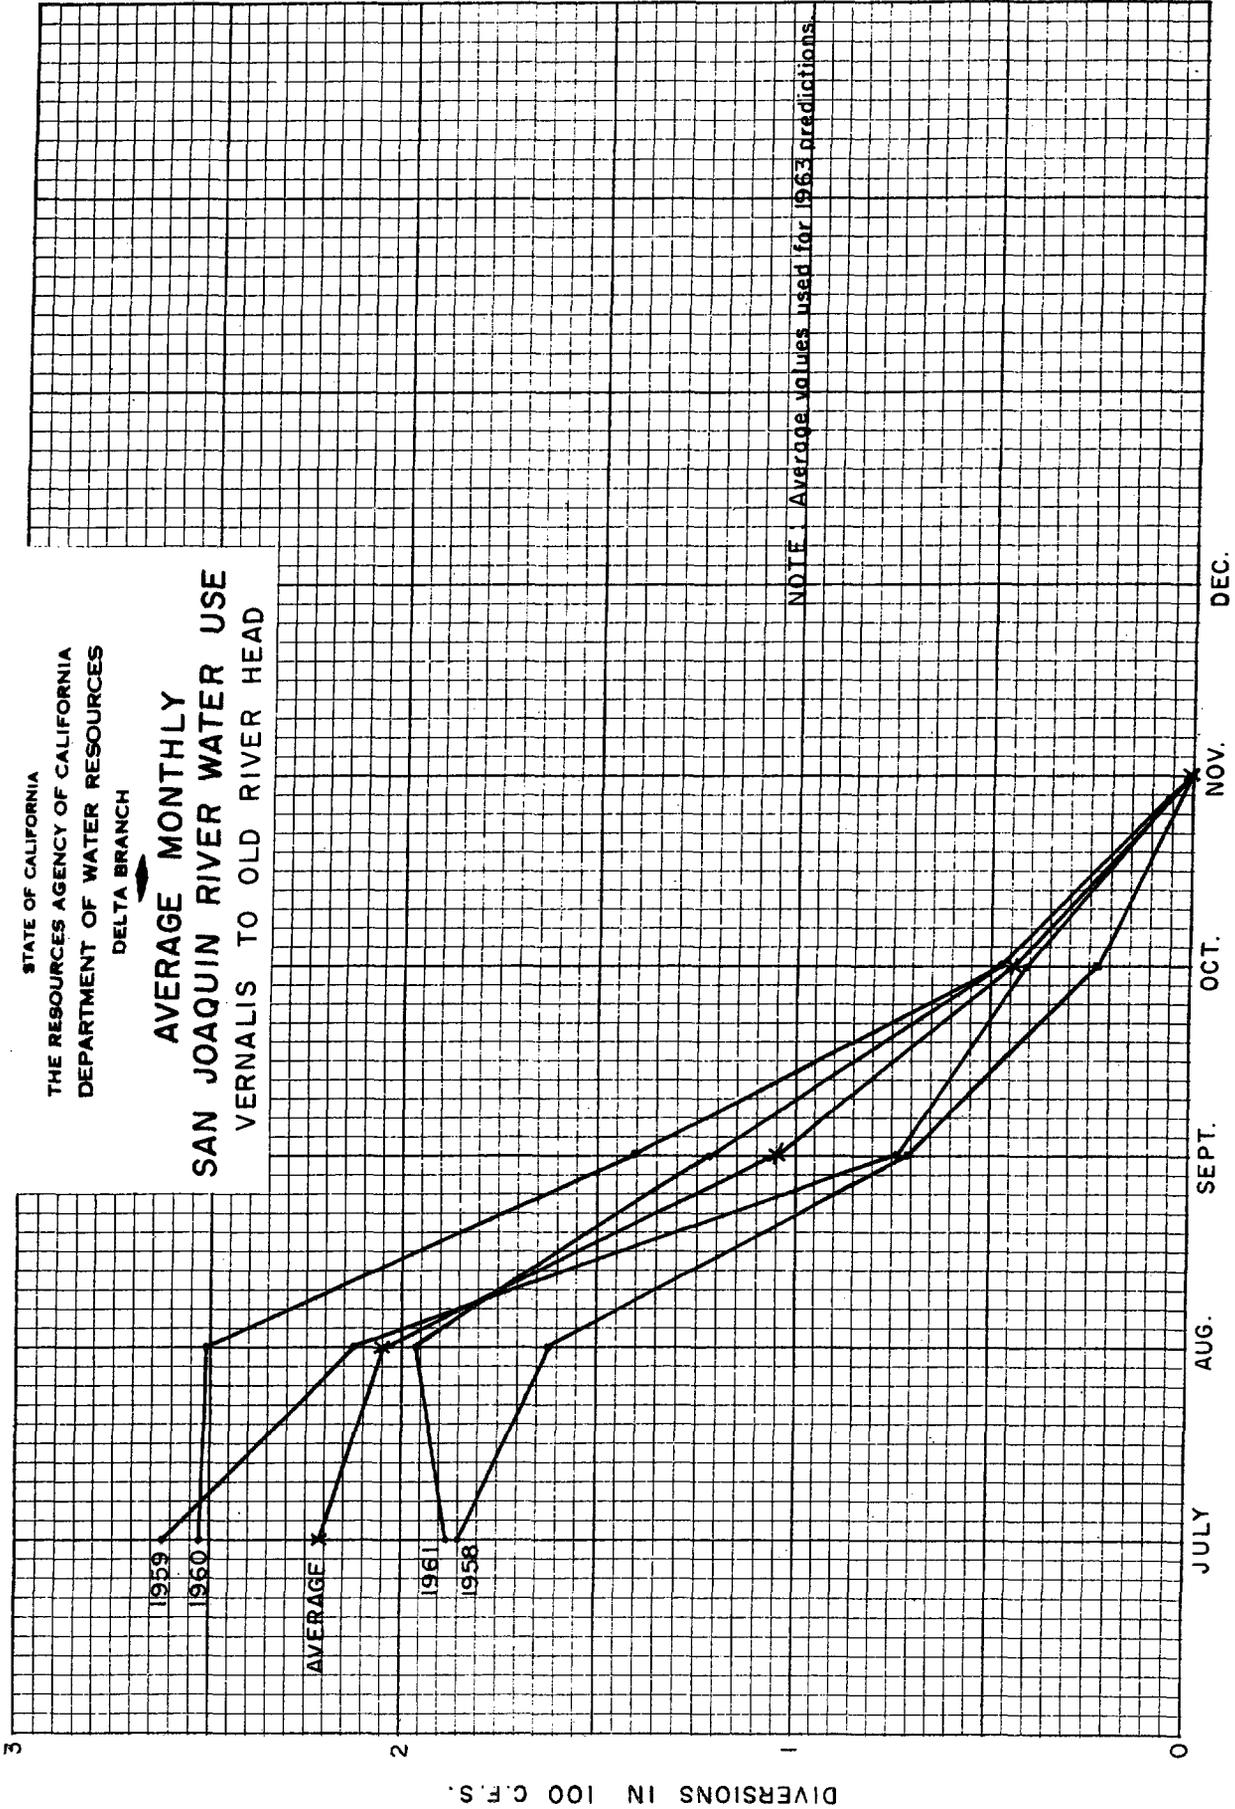
**AVERAGE MONTHLY  
SAN JOAQUIN RIVER WATER USE  
VERNALIS TO OLD RIVER HEAD**

NOTE: Average values used for 1963 predictions.

Flow in the San Joaquin River at Mossdale is the average flow at Vernalis less the diversions from Vernalis to Old River head. Plate 8 was then used to determine the amount of flow into Old River for the average Tracy pumping rate. The flow in the San Joaquin River at Stockton was then computed as Mossdale flow, less flow into Old River, less water diverted from the channel between Old River head and Stockton. These results provided the following values for predicted average monthly flows:

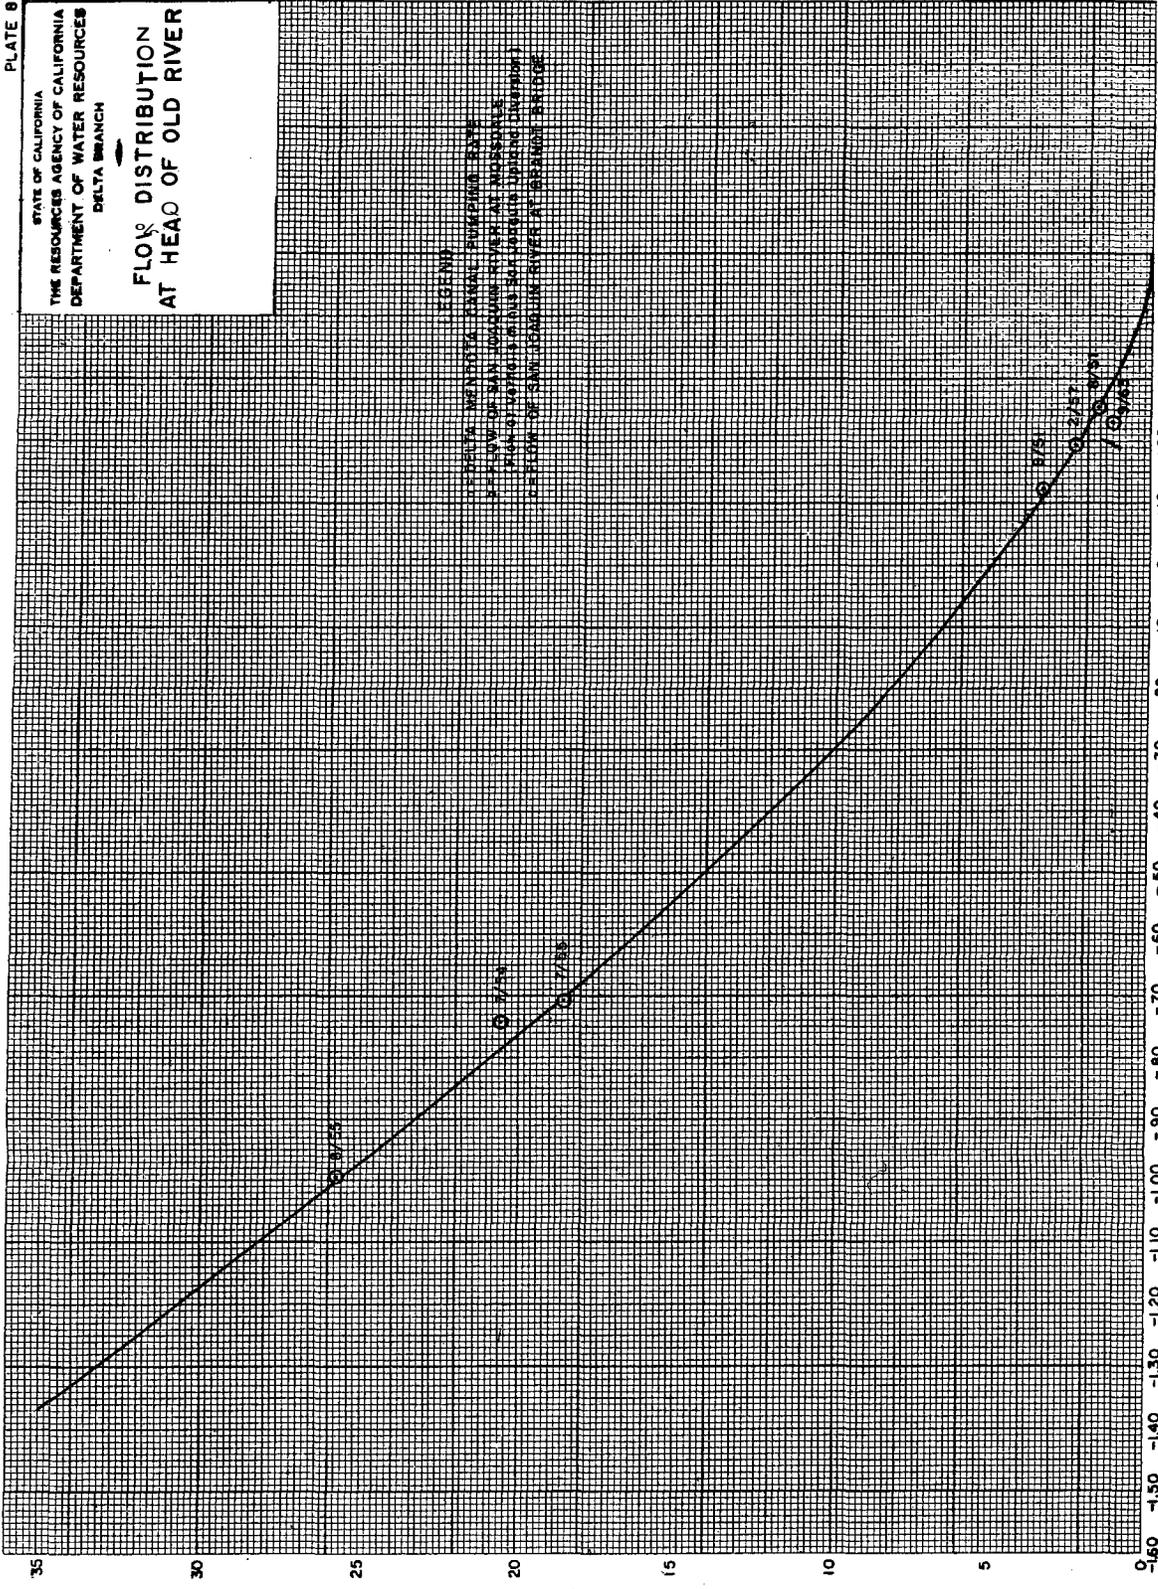
FLOW DISTRIBUTION  
AT HEAD OF OLD RIVER

LEGEND  
CENTRAL WENTZEL CANAL PUMPING RATE  
FLOW OF SAN JOAQUIN RIVER AT WASSUKALE  
FLOW OF OLD RIVER AT HEAD OF OLD RIVER  
FLOW OF SAN JOAQUIN RIVER AT BISHOP'S BRIDGE

Based on the prediction of a borderline condition for flow reversal and the fact that a pollution problem existed in the San Joaquin River, the decision was made to institute remedial measures to correct these conditions. The Bureau of Reclamation agreed to pump extra water at the Tracy **pumping** plant for release into the upper San Joaquin, Releasing began in mid September and continued through October as shown on Plate 11, When this method of operation failed to correct the pollution problem, the decision was made to install a partial closure in Old River, This installation coupled with continued pumping by the Bureau of Reclamation provided the desired results. The relative effect of each method is shown on Plate 9, Flows on Plate 9 are not actual 1963 flows and only serve to illustrate the relative benefit of each corrective **procedure**. Actual flows in the San Joaquin River are shown on Plate 10. These flows are calculated and are based on rated Vernalis flows and the curve of Plate 8. Flows during the time the closure was in place are based on a tidal flow measurement taken October 14 and 15, 1963, which showed a division of flow at Old River head of **52 percent in** San Joaquin, **48 percent in Old River**.

Prior to the closure the tidal flow measurement of September 18 and 19, 1963, showed a division of 77 percent Old River, 23 percent San Joaquin River. The September measurement and the October measurement cannot be directly compared, however, since the pumping rates during the two measurements were materially different (October = 2,800 cfs, September = 1,900 cfs). Actual flows for 1963. were computed based on the October tidal flow measurement and Plate 8. The flow past Stockton with the closure contribution and Bureau pumping contribution is shown on Plate 12.
