State of California
California Natural Resources Agency
Department of Water Resources
Bay-Delta Office

Efficacy Report
2015 Emergency Drought Barrier Project
June 2019

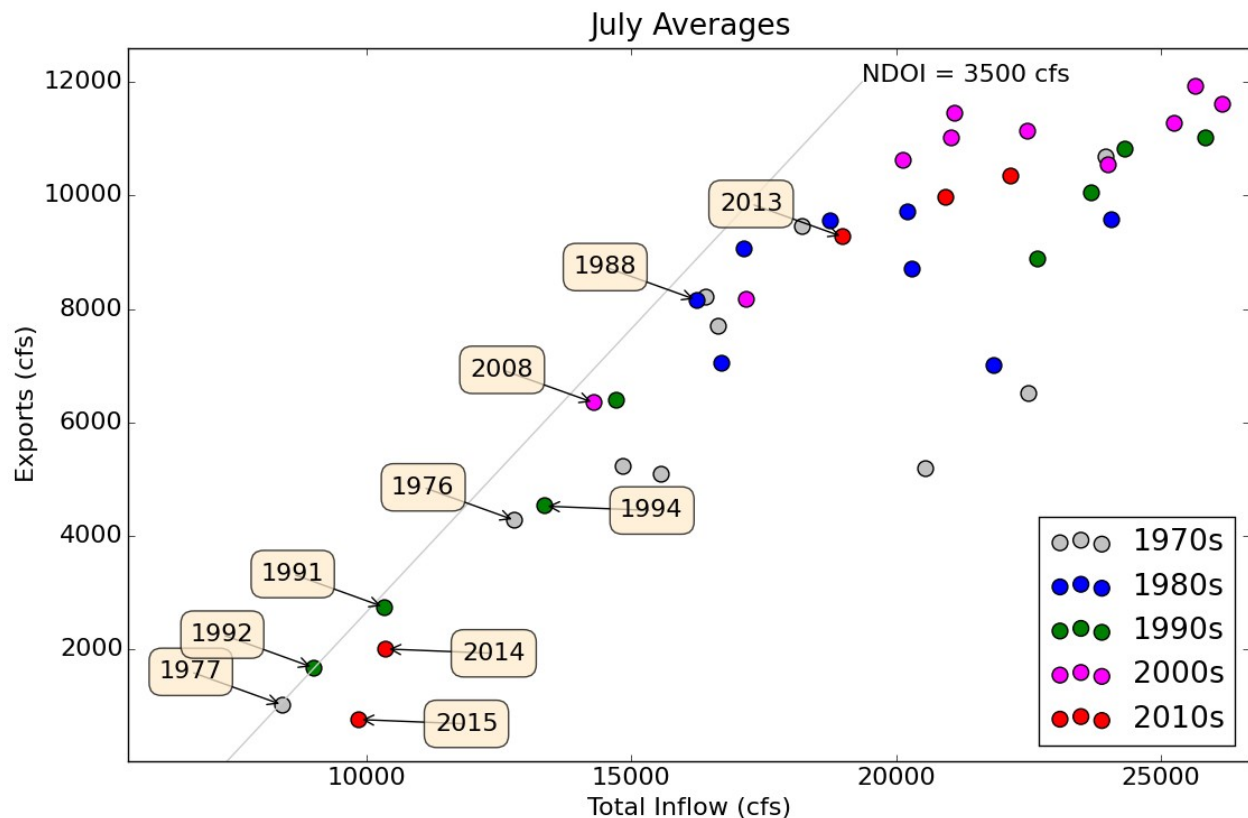
Figure 1-2 Inflow and Exports to the Delta (DAYFLOW) From 1970 to 2015

Note: Three outlier years are omitted. The gray line indicates combinations of inflow and outflow that yield NDOI of 3,500 cfs for July.

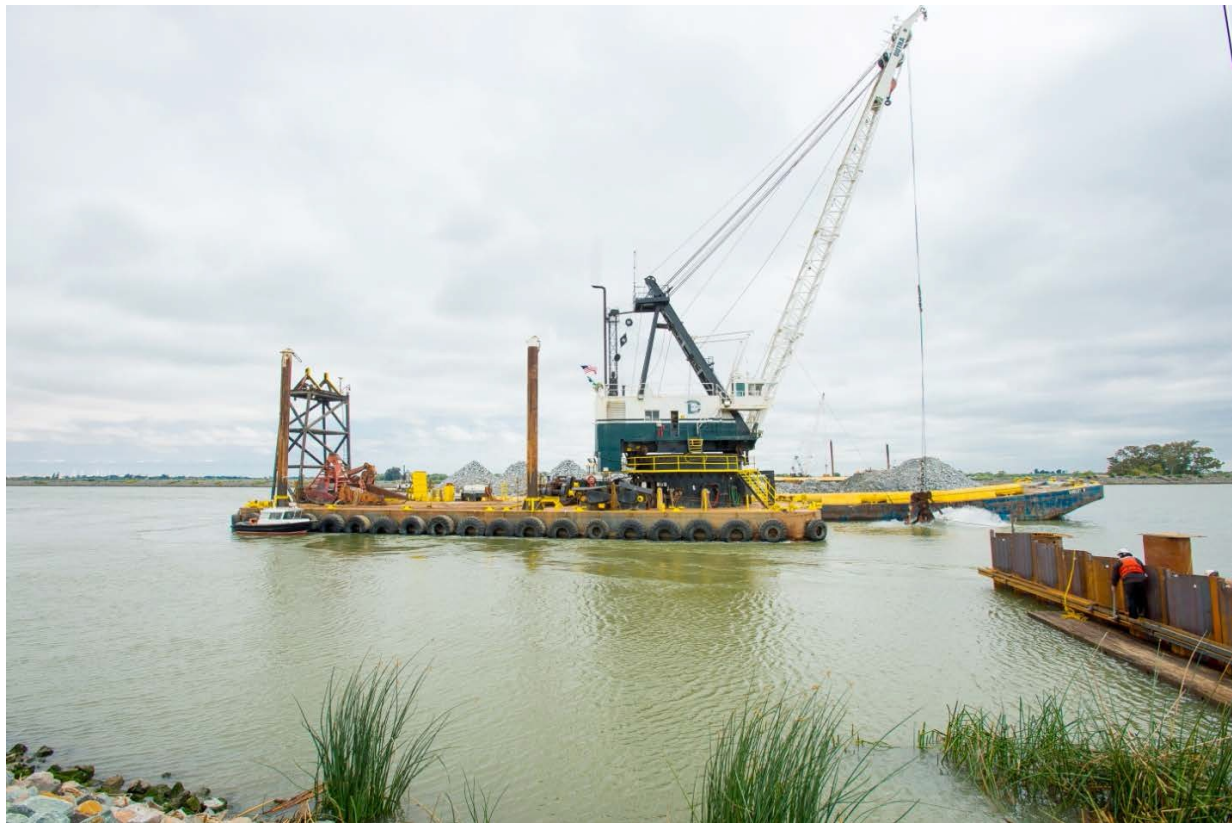
Figure 3-4 Rock Placement During EDB Installation

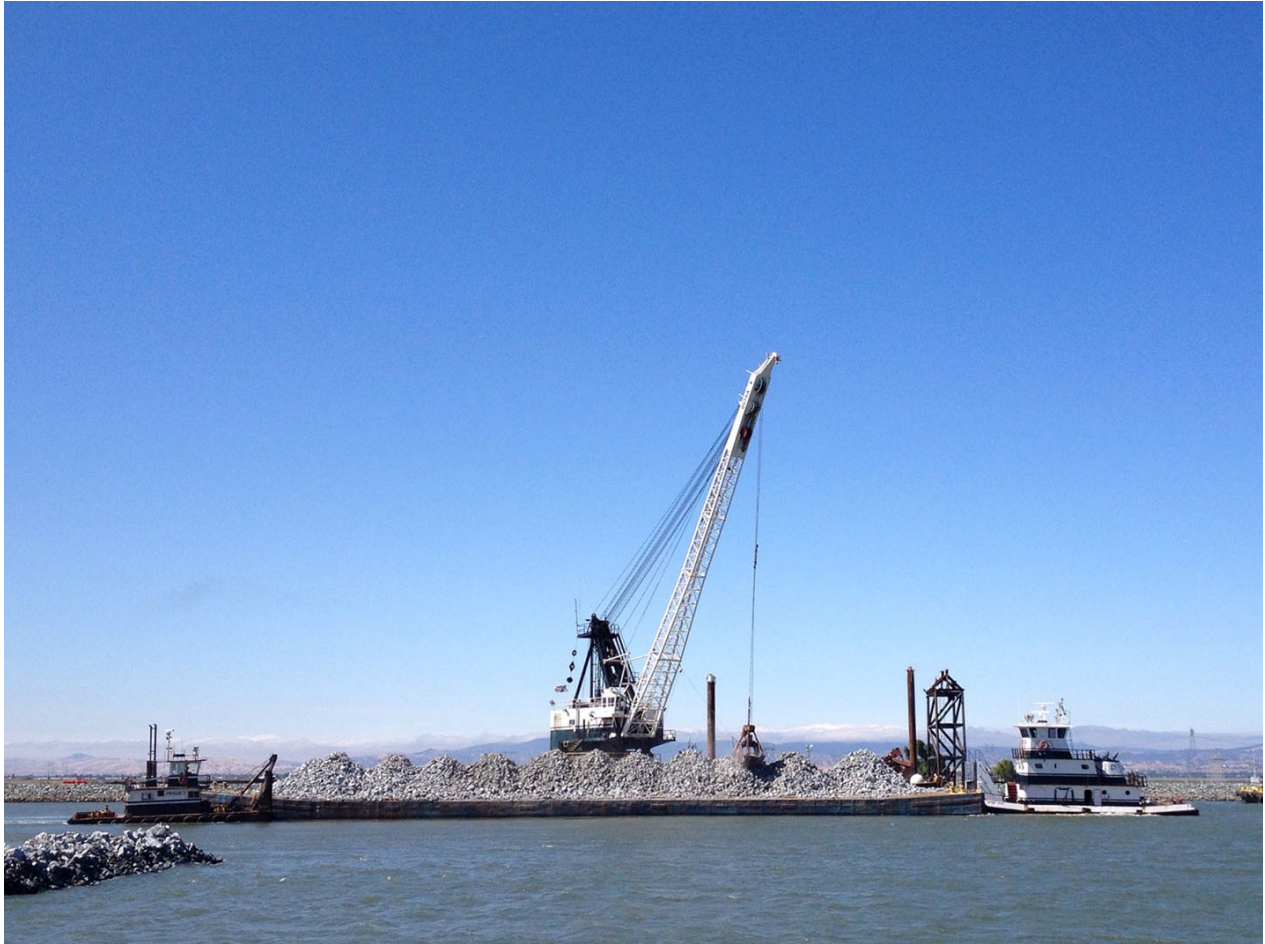
Figure 3-5 Rock Placement During EDB Installation

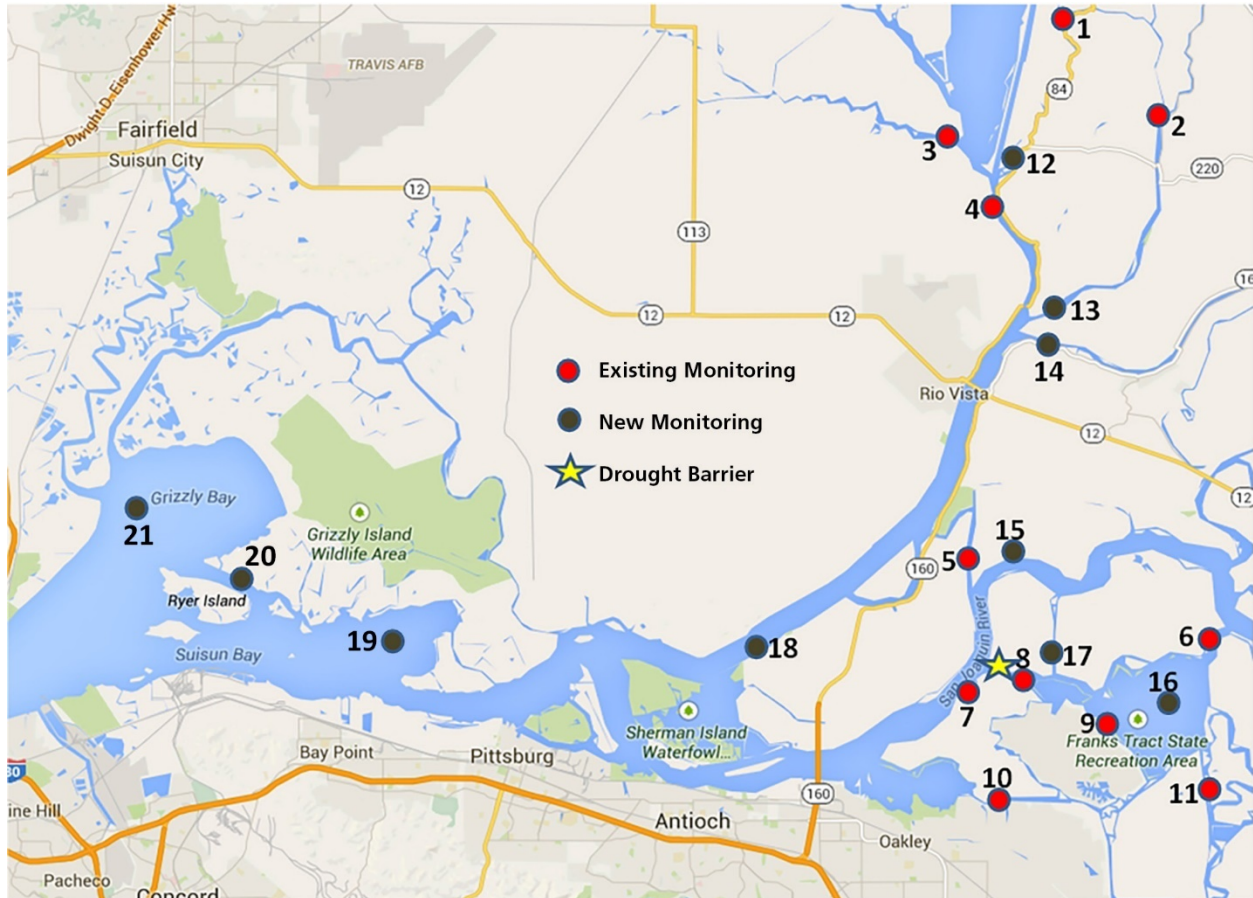
Figure 3-6 Locations of Water Quality Monitoring Stations

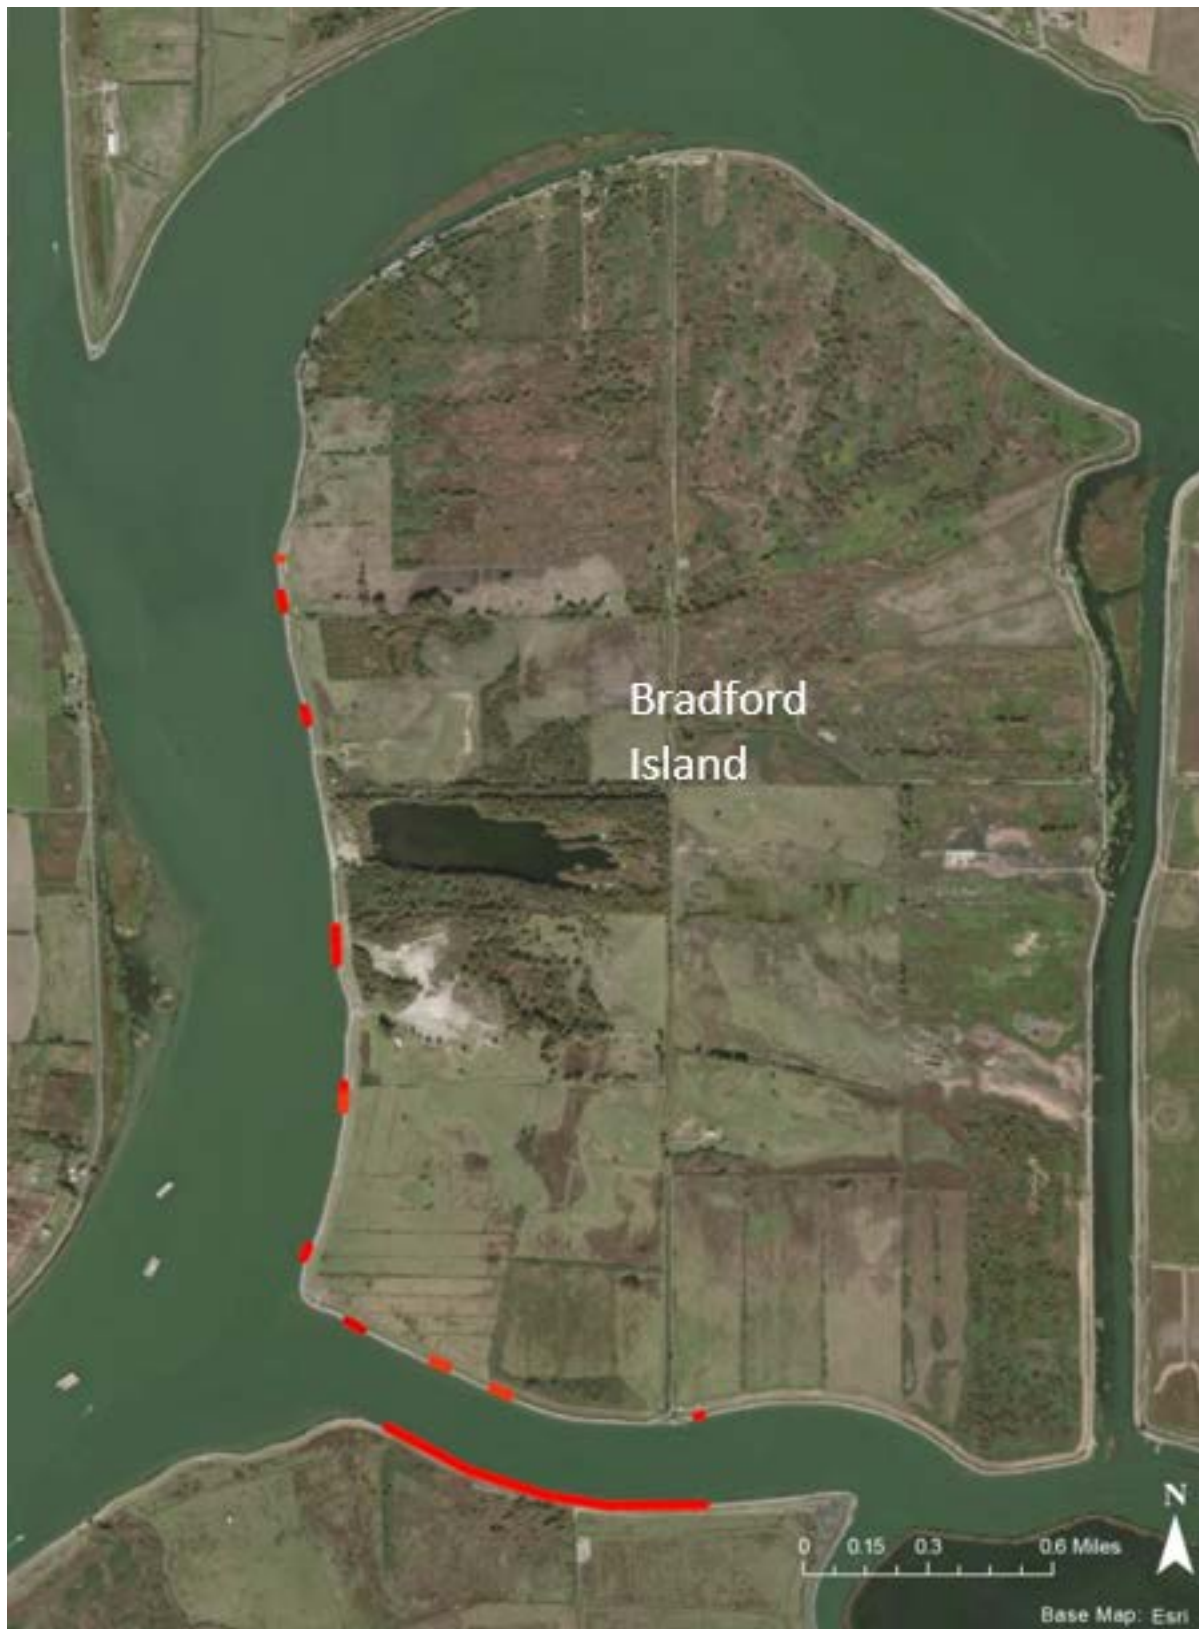
Figure 3-11 Areas of Levee Undercutting

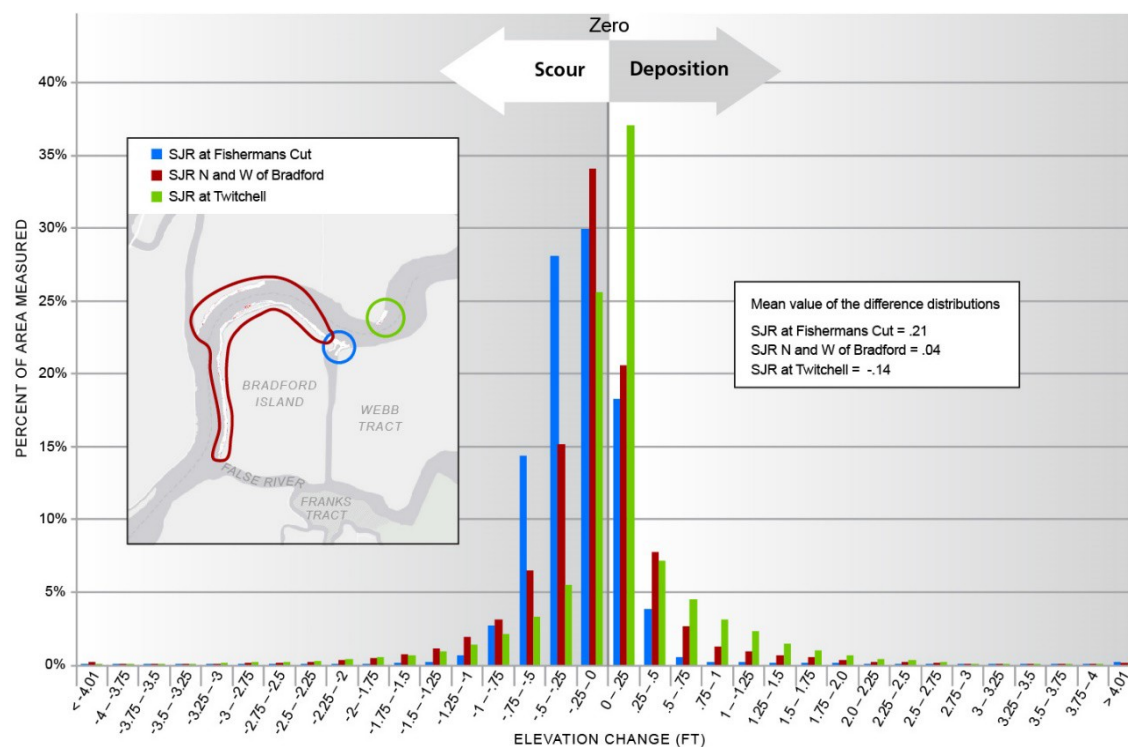
Figure 3-13 Histograms of Elevation Change at Various Locations

Note: This difference in elevations is expressed as percent area v. the amount of change seen in those areas.

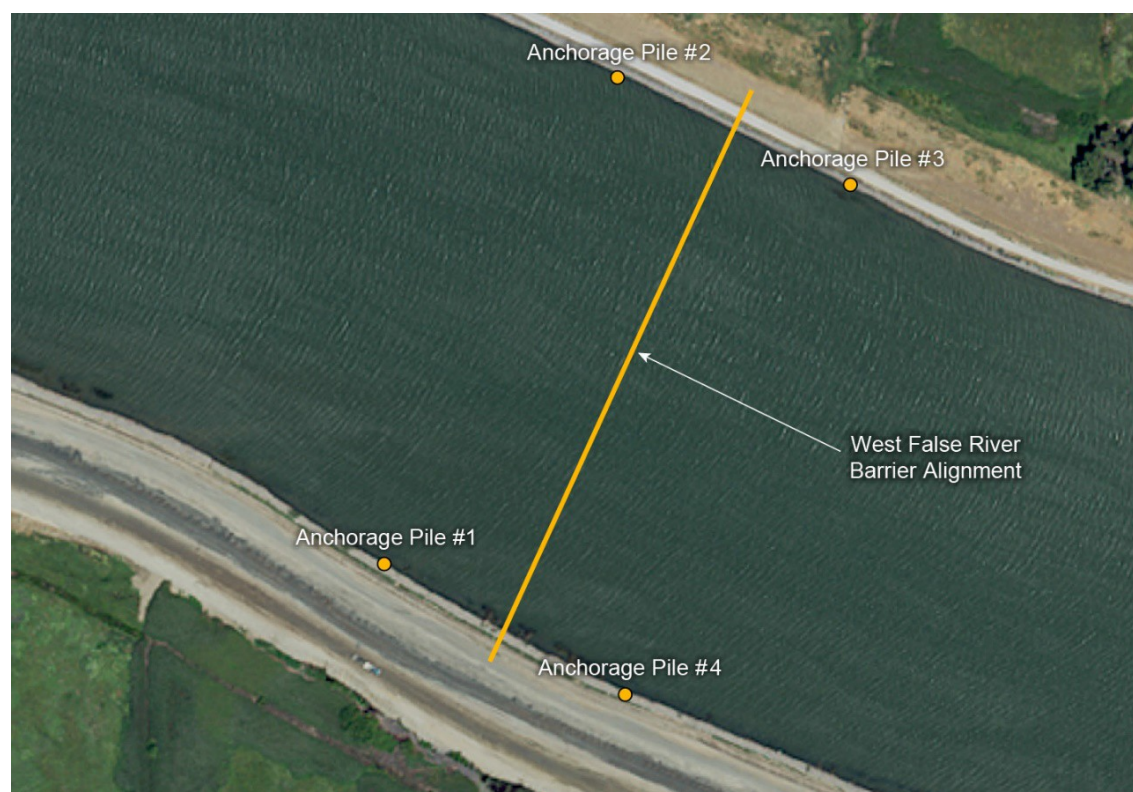
Figure 3-14 Location of Navigational Aid Ball Float Anchorage Piles

DWR coordination with the U.S. Coast Guard (USCG) on navigation was one of the issues that needed to be addressed for implementation of the 2015 EDB. For the 2015 EDB, DWR’s BDO established contact with the USCG Alameda Headquarters Office, District 11. Notices to Delta boaters and navigation aids needed to be provided for the EDB, as well as for the 10 new monitoring station piles installed in the north Delta, central Delta, and Suisun Bay as part of the 2015 EDB Project. Details needed to be provided for the navigational aids plans, the construction schedule, and the details for driving the piles that would house the monitoring network equipment and safety lights. Navigation aid anchorage piles were also proposed upstream and downstream of the EDB, as shown in Figure 3-14 and summarized in Table 3-4.

Pile #	Latitude	Longitude	Length	Tip Elevation	Head Elevation
Pile 1	38.0568901	-121.6725178	40 feet	-28.0 feet	+12 feet
Pile 2	38.0589375	-121.6713667	40 feet	-28.0 feet	+12 feet
Pile 3	38.0584605	-121.6701145	40 feet	-28.0 feet	+12 feet
Pile 4	38.0563749	-121.6712871	40 feet	-28.0 feet	+12 feet

To mitigate navigational impacts, a navigational aid plan was prepared by DWR and provided to USCG. The plan was approved by USCG and implemented during installation, operation, and removal of the 2015 EDB. During pile installation, efforts were made to stay out of the navigation channel; most piles were about 15 to 30 feet away from the shore, with only two in open water because of channel bottom conditions. Signage and lights were installed upon completion of pile driving per USCG requirements, including a white light with a visibility of 3 miles that flashes every 4 seconds for 0.5 second per flash and an 18 x 18 inch "Danger" sign on top of each pile. All piles remained in the channel. No navigational incidents were reported during any phase of the 2015 EDB Project.

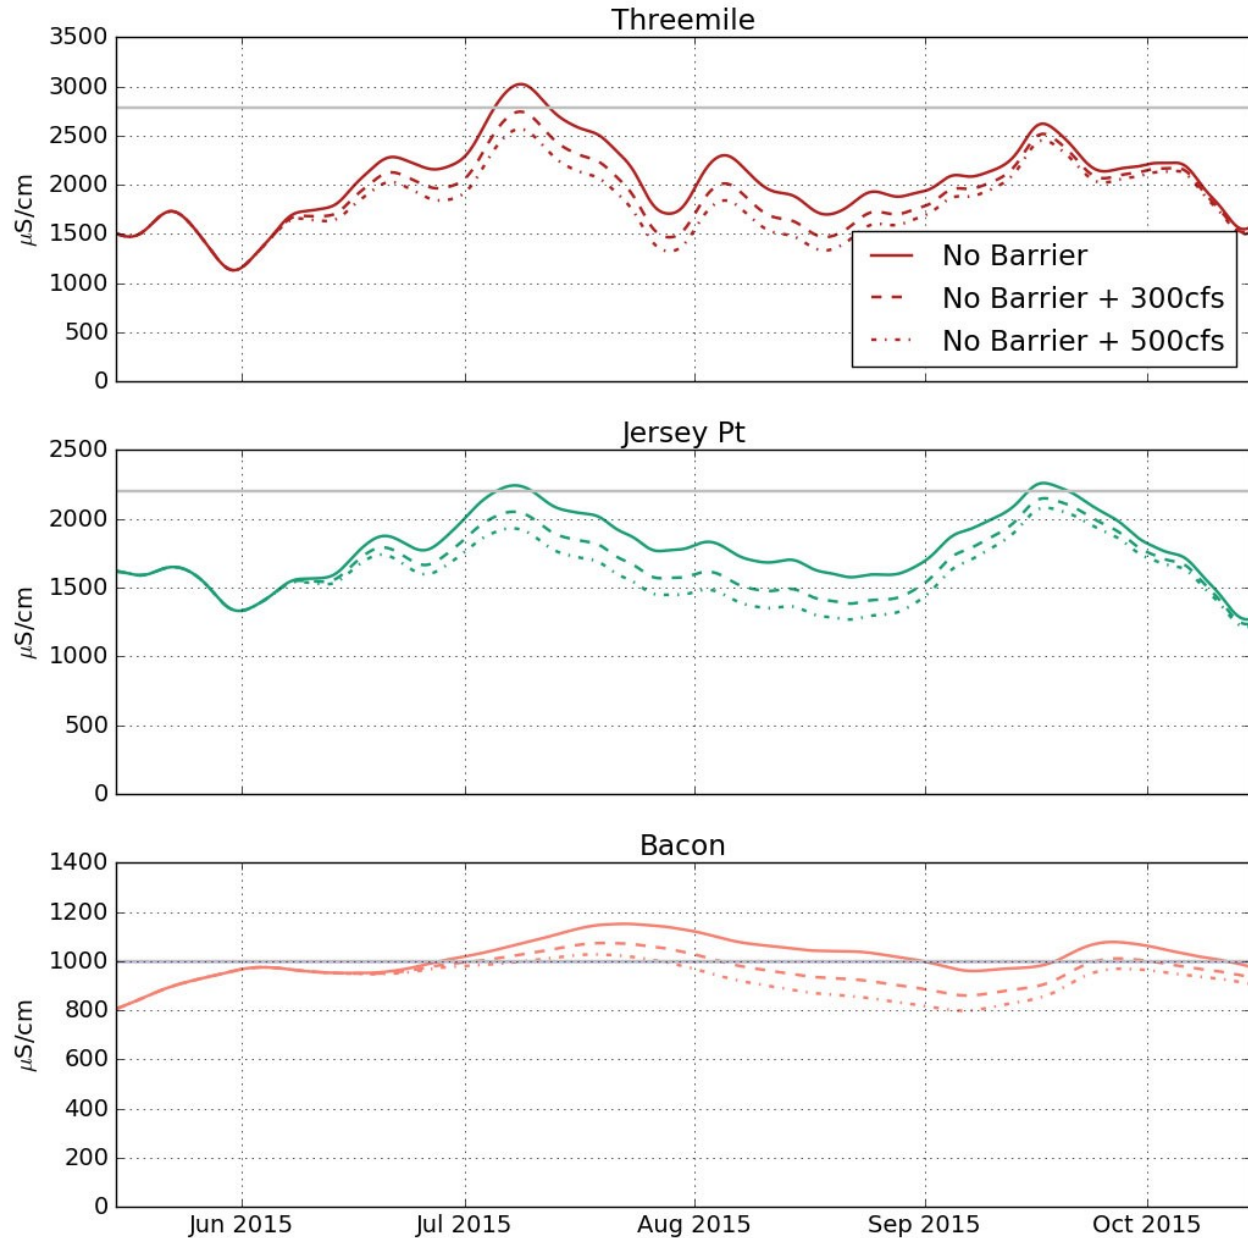
Figure 4-10 Modeled Conductivity at the Three Most Likely Limiting Compliance Locations Under the TUCP With no Barrier: Three Mile Slough at the Sacramento River, Jersey Point, and Bacon Island at Old River

Note: The gray line shows the applicable D-1641/TUCP objective; note that Three Mile Slough and Jersey Point are agricultural objectives that do not apply after August 15.

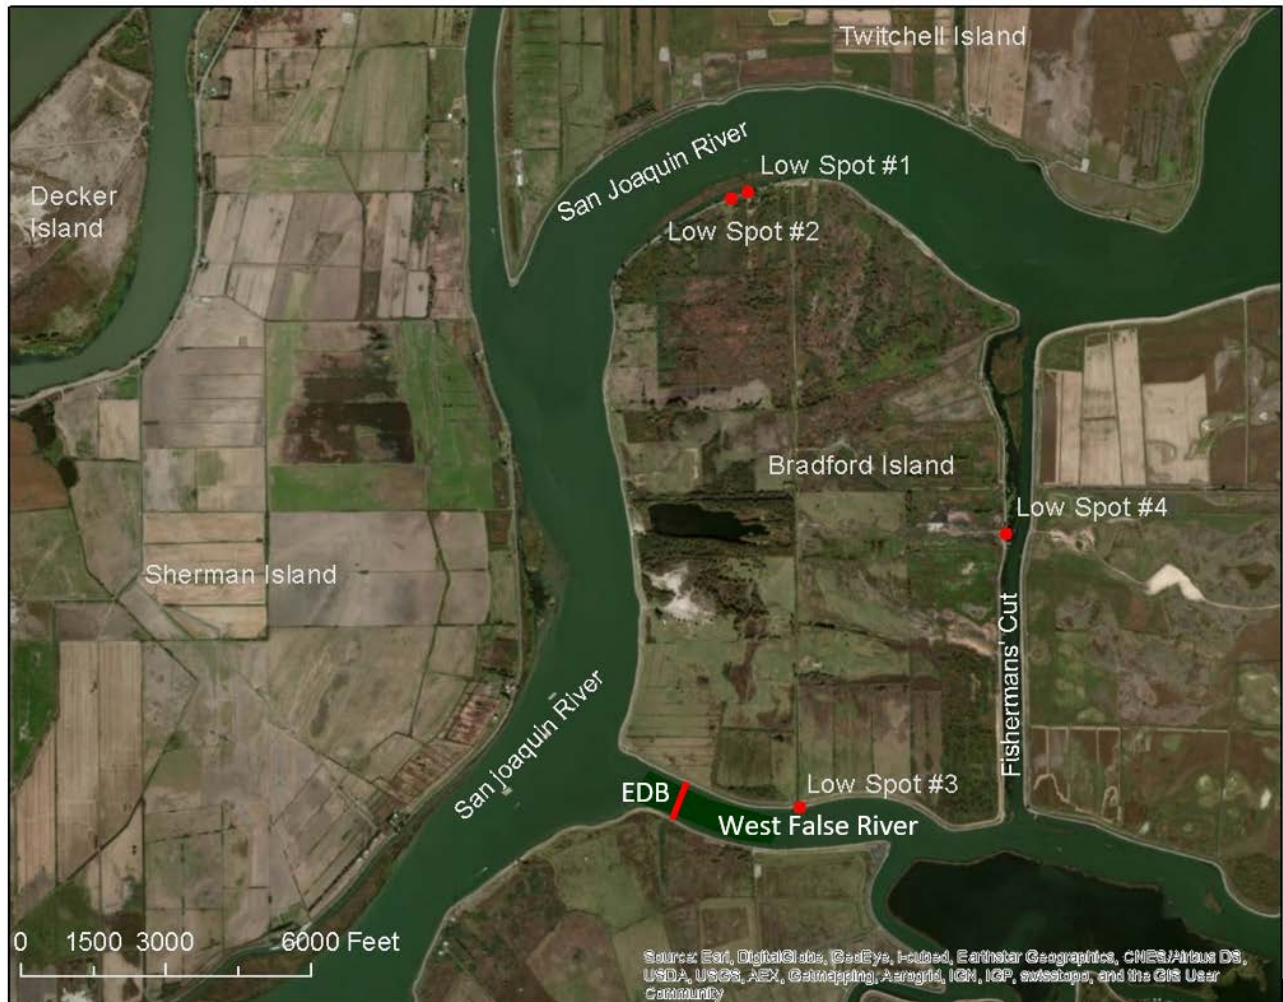
Figure 4-12 Low/Vulnerable Sections of Levees Identified by DWR and RD 2059

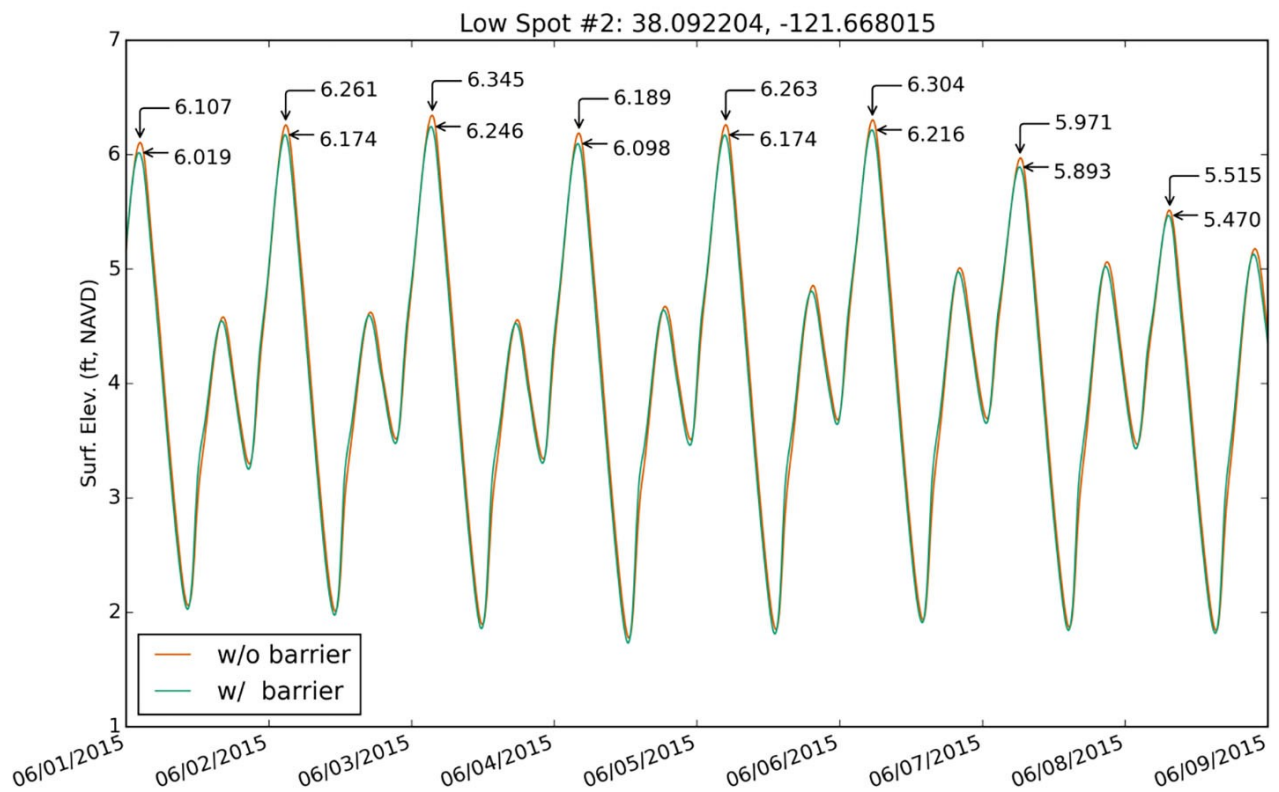
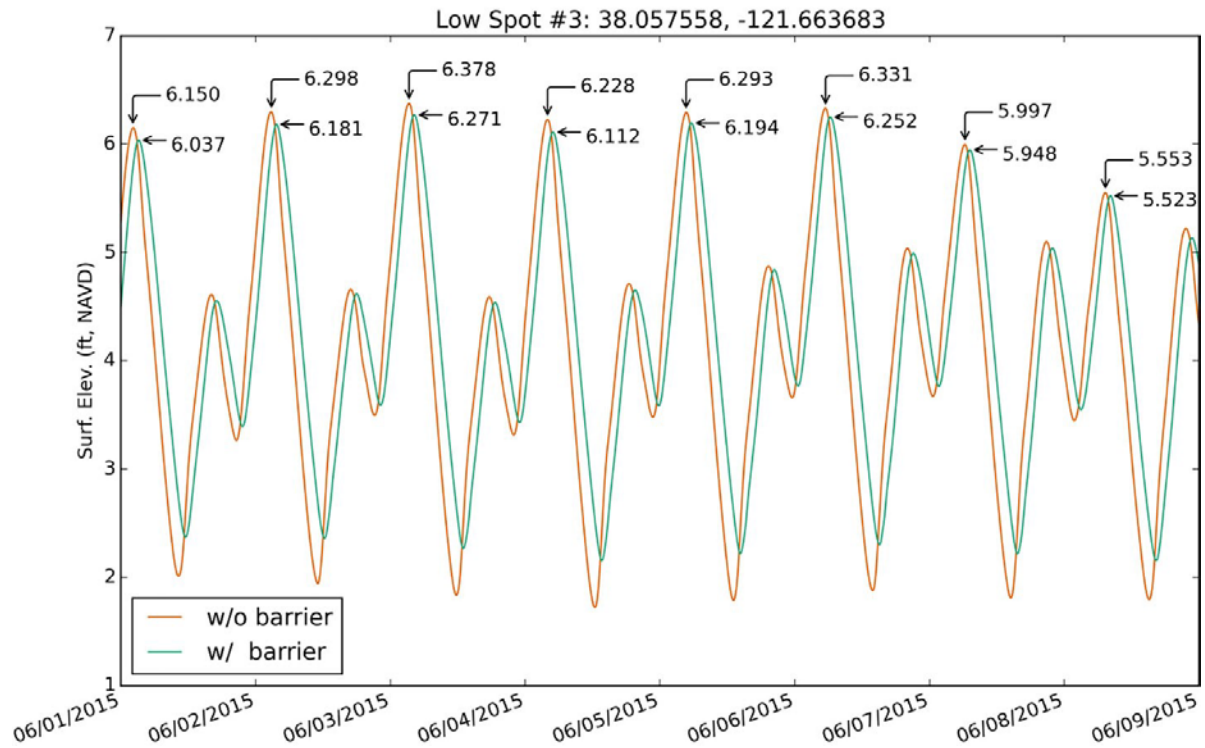
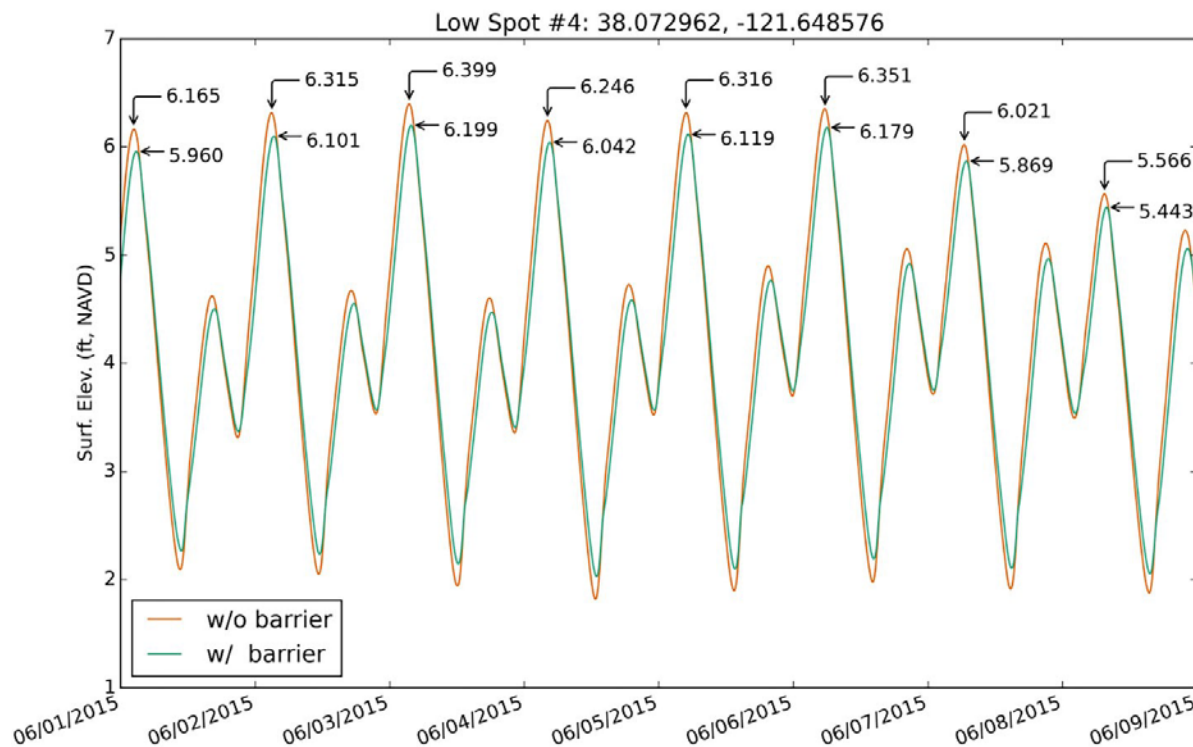
Figure 4-14 Simulated Water Levels for Low Spot #1 With Daily Maximum Values Labeled

Figure 4-15 Simulated Water Levels For Low Spot #2 With Daily Maximum Values Labeled

Figure 4-16 Simulated Water Levels For Low Spot #3 With Daily Maximum Values Labeled

Figure 4-17 Simulated Water Levels For Low Spot #4 With Daily Maximum Values Labeled

The modeled differences introduced by the EDB at the individual levee “low spots” are shown as time series in Figure 4-14 through Figure 4-17. At all four locations, the EDB caused a minor reduction in maximum water levels, typically around 0.1 foot but up to 0.2 foot at Low Spot #4.

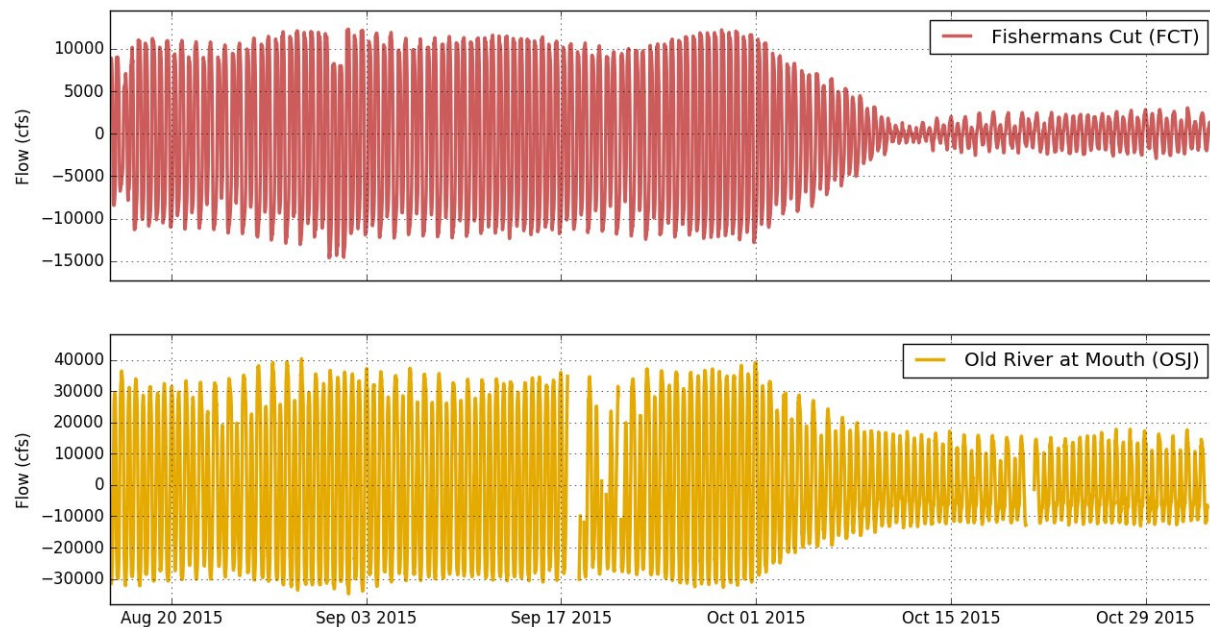
Figure 4-18 Changes in Tidal Range of Flow, Fisherman's Cut and Mouth of Old River

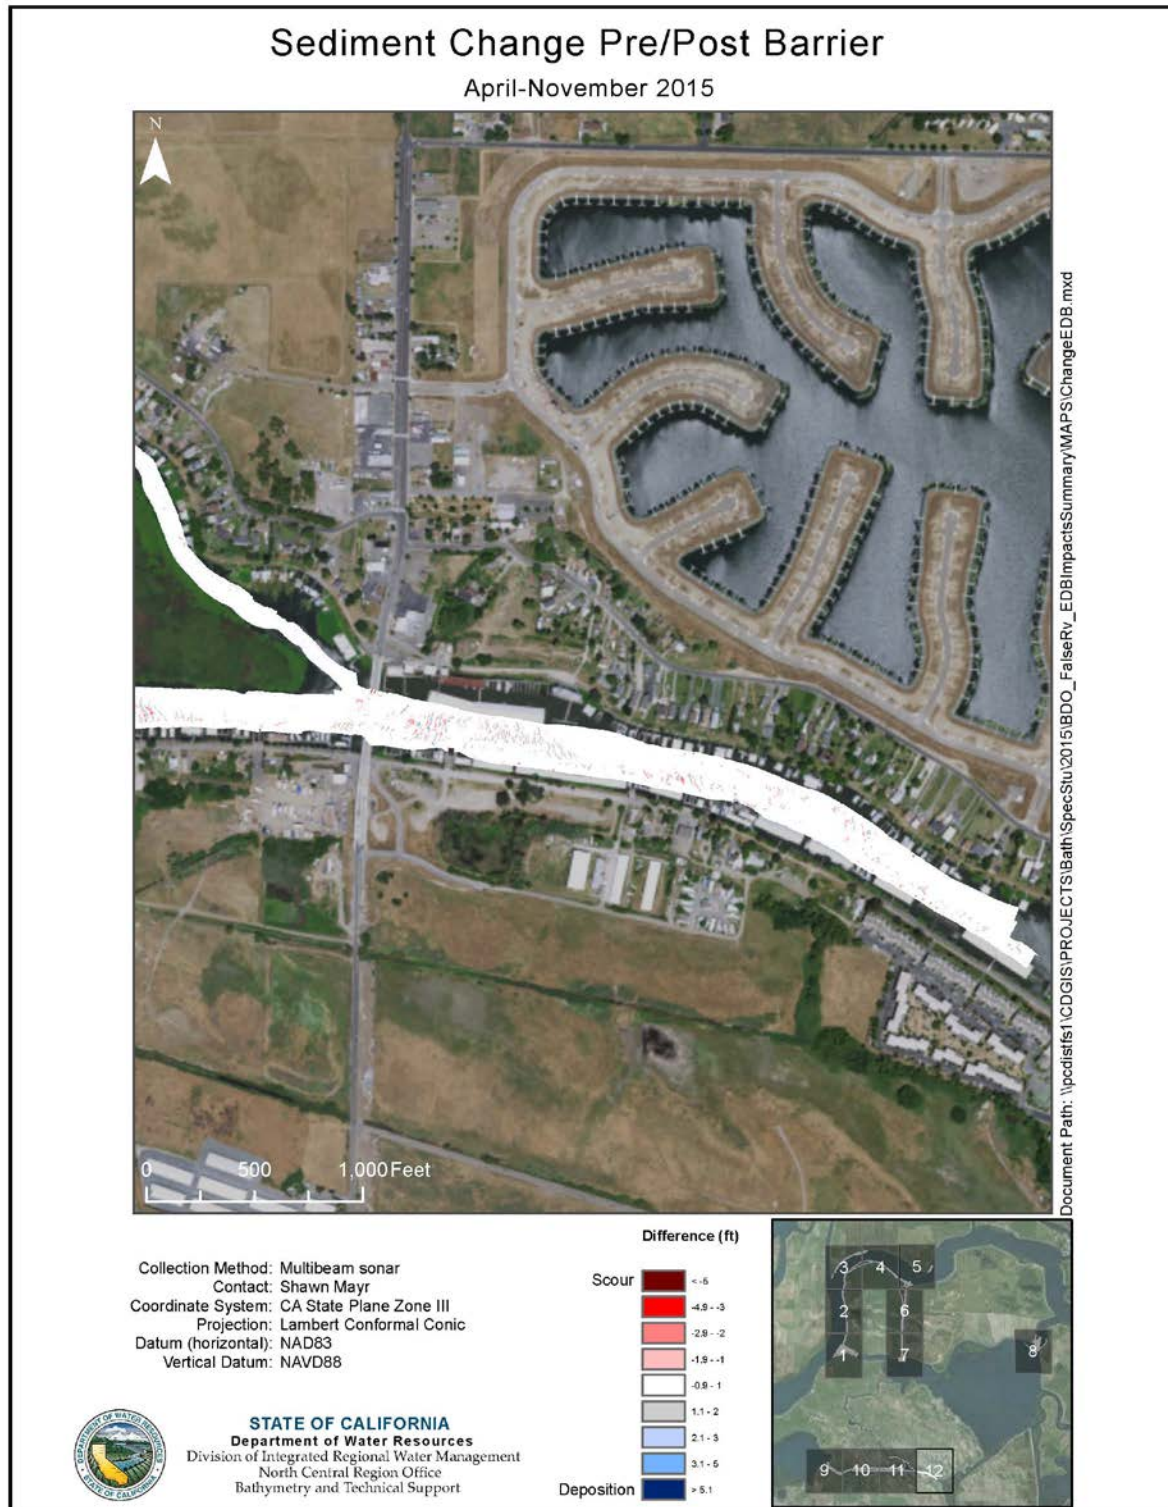
Figure A-7 Sediment Change Pre/Post Barrier Around the Confluence of False River and Fishermans Cut Between Bradford Island and Webb Tract

Figure A-8 Sediment Change Pre/Post Barrier Along Old River Near Franks Tract

Figure A-9 Sediment Change Pre/Post Barrier Along Dutch Slough Near Big Break

Figure A-10 Sediment Change Pre/Post Barrier along Dutch Slough Near Jersey Island Road

Figure A-11 Sediment Change Pre/Post Barrier Along Dutch Slough and Taylor Slough

Figure A-12 Sediment Change Pre/Post Barrier Along Dutch Slough Near Bethel Island Cove
