OROVILLE SPILLWAYS RESPONSE & RECOVERY 2017-2018

KEY MILESTONES

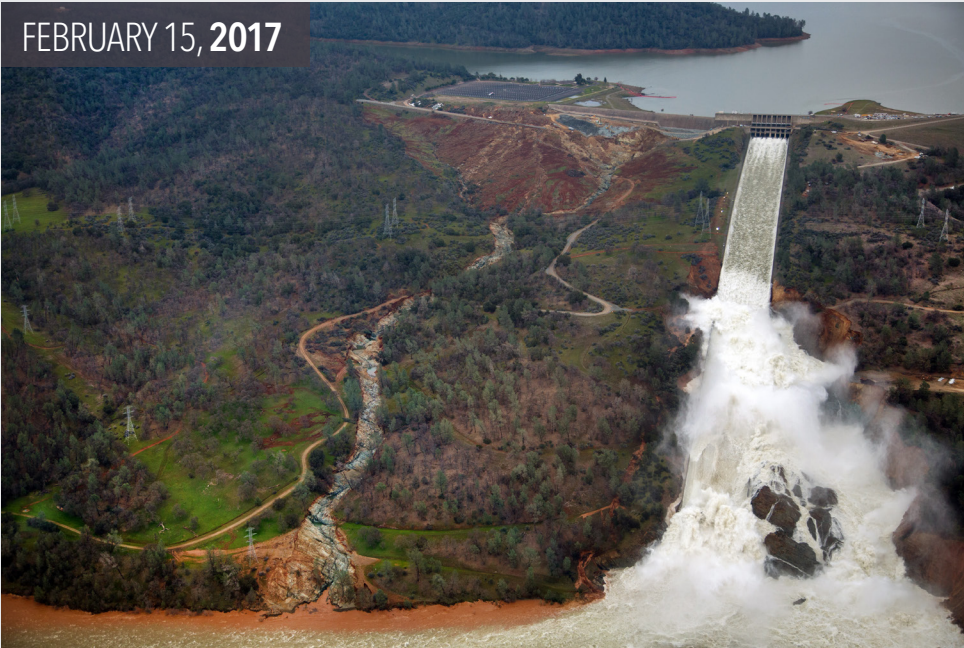
FEBRUARY 15, 2017

Lake Oroville damaged main spillway with an outflow of 100,000 (cfs).

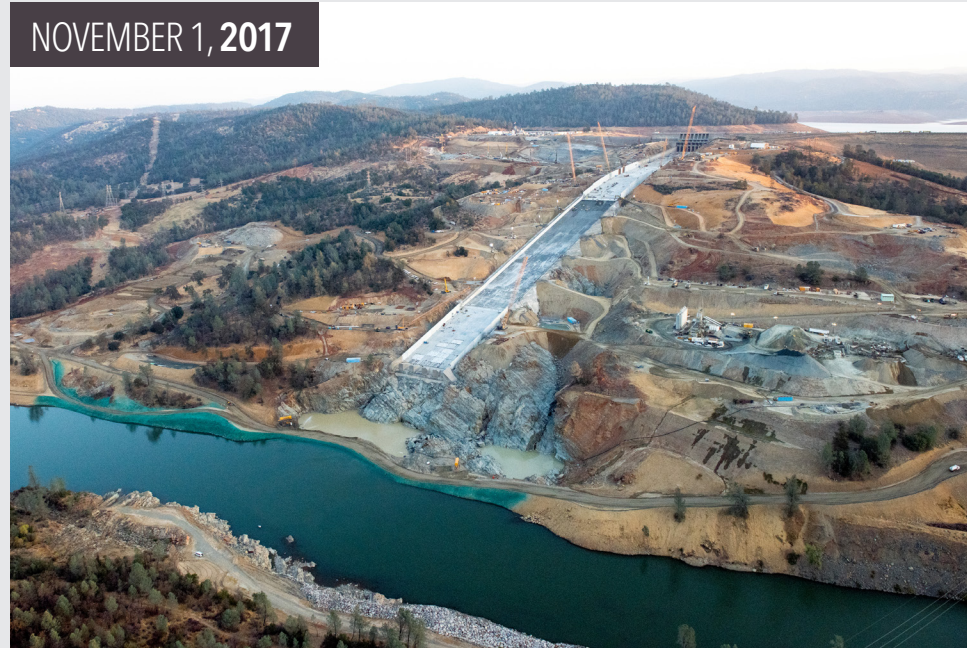
NOVEMBER 1, 2017

Phase 1 repairs to main spillway allowed outflows of 100,000 (cfs), if necessary, during upcoming winter season.

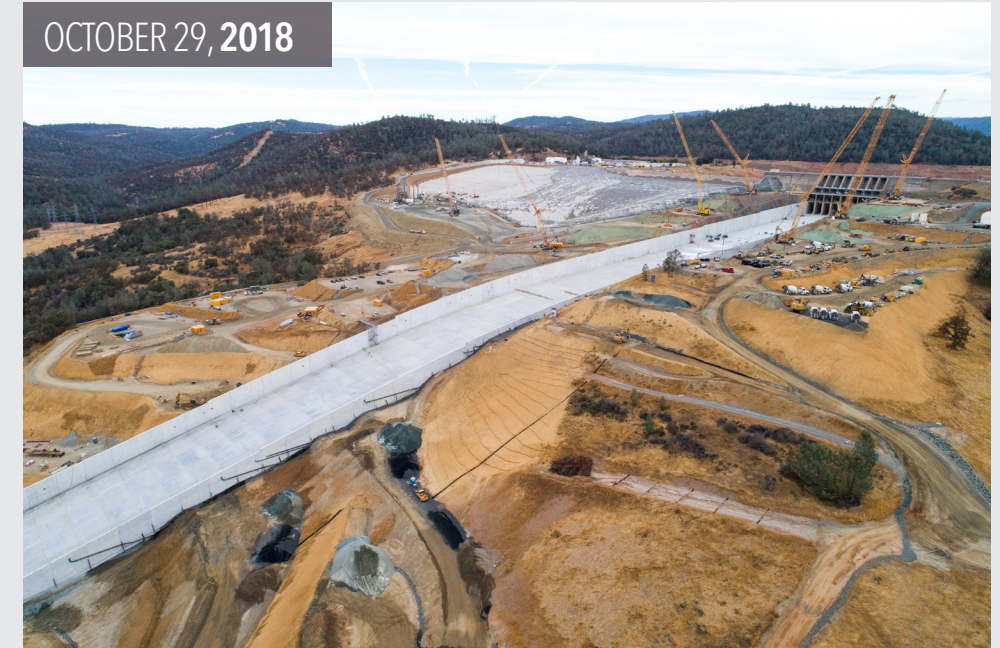
OCTOBER 29, 2018

Final concrete work on the upper chute of main spillway and the emergency spillway.

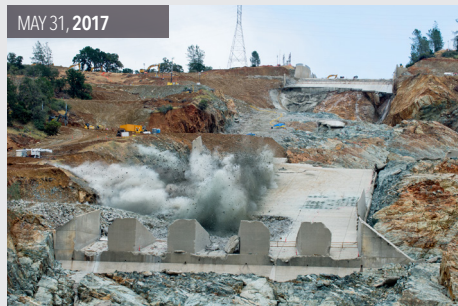
MAY 31, 2017

Controlled blasting. A detonation breaks up concrete from the lower chute of the damaged main spillway.

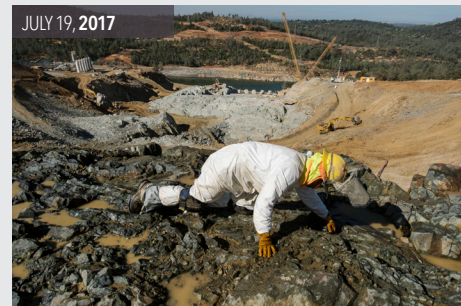
JULY 19, 2017

Cleaning bedrock. Workers remove loose rocks and debris in preparation for placement of concrete on the upper chute of the main spillway.

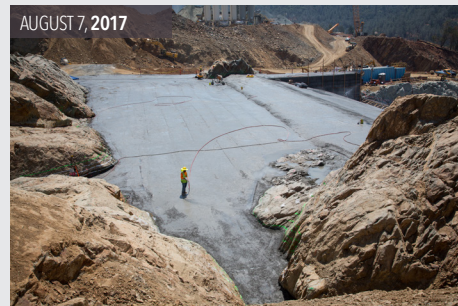
AUGUST 7, 2017

Roller-Compacted Concrete (RCC). To facilitate curing, water is sprayed on RCC in an erosion area between the upper and lower chutes of the main spillway.

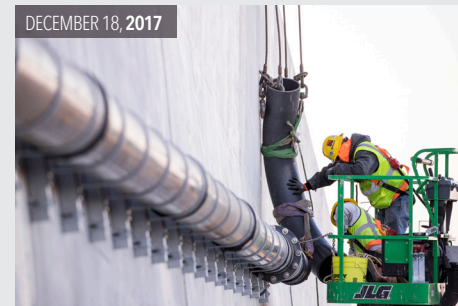
DECEMBER 18, 2017

Drainage system. Drainage pipes are connected to the outer sidewalls of the upper chute of the main spillway.

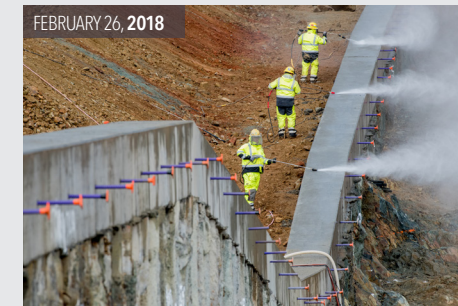
FEBRUARY 26, 2018

1,450-foot secant wall. A concrete beam anchored to the top of the secant pile wall forms the base of the roller-compacted concrete splashpad.

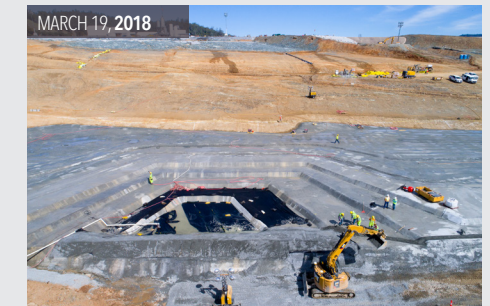
MARCH 19, 2018

Construction of RCC splashpad. Armored the hillside between the emergency spillway and secant pile wall to prevent erosion should the emergency spillway flow.

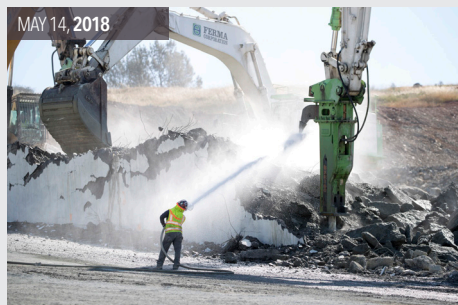
MAY 14, 2018

Middle chute berm demolition. Temporary RCC sidewalls are removed from main spillway prior to placement of permanent structural concrete walls.

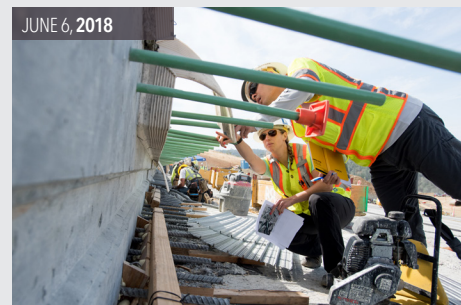
JUNE 6, 2018

Inspection work. DWR engineers check the leading edge of the upper chute where new structural concrete work will be poured on main spillway.

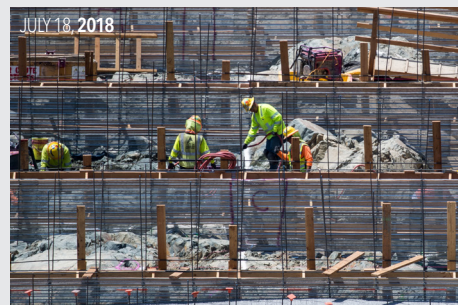
JULY 18, 2018

Stay-forms. Workers prepare for placement of leveling concrete on the upper chute of the main spillway.

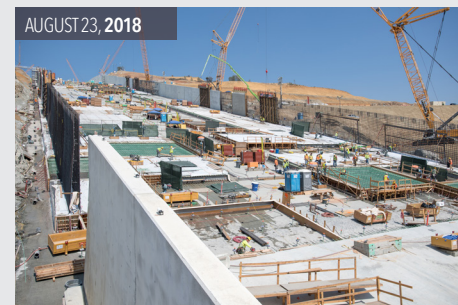
AUGUST 23, 2018

Structural concrete. Crews place structural concrete on middle and upper chutes of the main spillway.

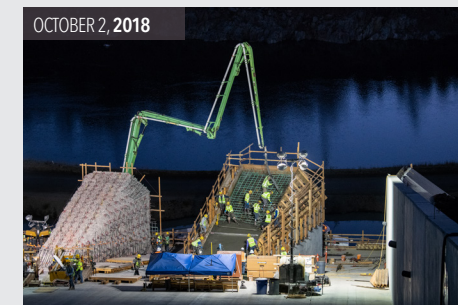
OCTOBER 2, 2018

Energy dissipator repair. Concrete is placed atop an energy dissipator block on the lower chute of the main spillway.

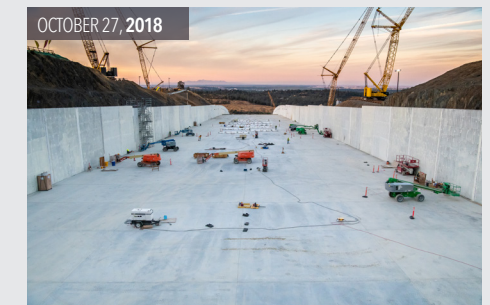
OCTOBER 27, 2018

Concrete finishing. Workers dry finish concrete slabs and sidewalls on the upper chute of the main spillway.
