3-002.01 CORRALITOS - PAJARO VALLEY

Basin Boundaries

Summary

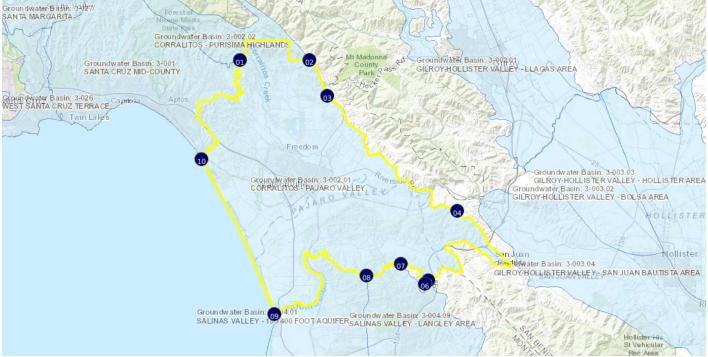
3-002.01 CORRALITOS - PAJARO VALLEY

The Pajaro Valley groundwater subbasin is a portion of the Corralitos Basin, located in Santa Cruz and Monterey counties. The northern boundary of the subbasin is the northern boundary of the Pajaro Valley Water Management Agency. The eastern boundary of the subbasin is the San Andreas Fault, adjacent pre-Quaternary formations, and the Santa Cruz Mountains. The southern boundary of the subbasin is comprised of the pre-Quaternary formations and the southern boundary of the Pajaro Valley Water Management Agency. The subbasin is bounded on the west by Monterey Bay. The basin boundary is defined by ten (10) segments detailed in the descriptions below.
